Fannie Stebbins Wildlife Refuge
Final Report of 2017-19 Floodplain Forest Restoration
The Nature Conservancy

By Karen Lombard, Project Manager

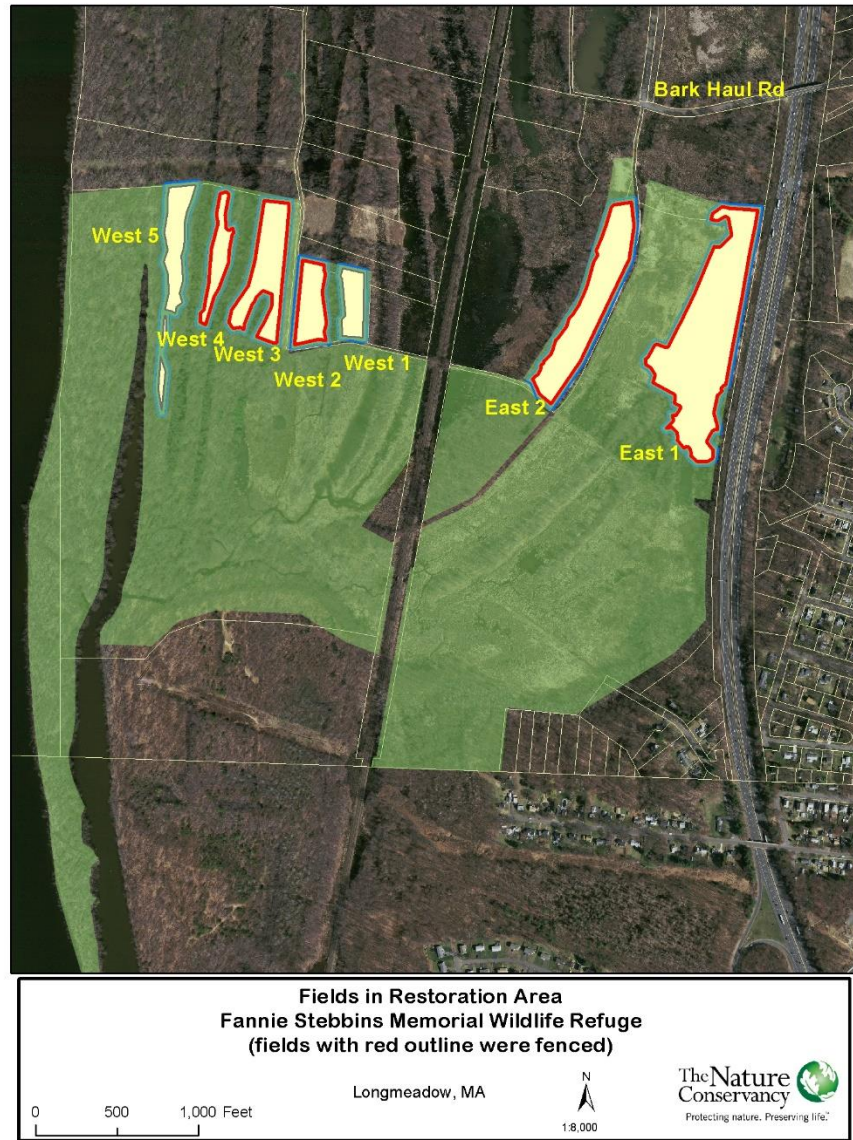
Figure 3: Fields where plantings were located. Both east fields as well as fields west 2-5 were fenced after the 2019 plantings.

We planted 7,892 trees, shrubs and ferns over two years in the seven old fields (Appendix A) and along a ridge south of the western most field (West 5) (Figure 3). Species selection was guided by nine years of previous research at over 100 floodplain forest sites along the Connecticut River (Marks et al. 2014; Marks & Canham 2015), with a focus on sites near Longmeadow, MA. A planting plan was developed based on flood duration, climate, soil pH, and different floodplain topographic features (see Marks et al. 2016 for details). The purpose of planting in the ridge was to fill canopy gaps cleared of invasive shrubs

with shade tolerant native tree species. Planting stock was sourced locally and primarily grown by New England Wetland Plants and Sudbury West.

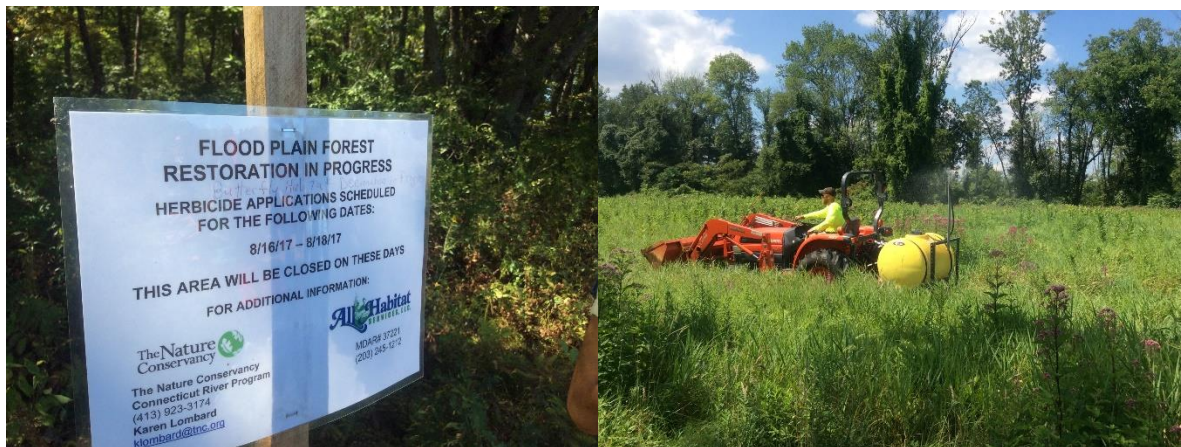
Figure 4: Herbicide control of herbaceous vegetation in fields in summer 2017

Initial vegetation control in the fields occurred in summer 2017 to control herbaceous vegetation (Figure 4). The fields were disked before planting in spring 2018 to expose bare soil for natural silver/red maple and cottonwood recruitment (Figure 5). Species were planted four meters apart with the goal of approximating 250/stems per acre (Figure 5). Planting was completed in April and May of each year (Figures 6 & 7). Vegetation control around plantings was accomplished mid-summer in 2018 and 2019. The original species list in the restoration plan was modified to what was available for purchase (Appendix A).

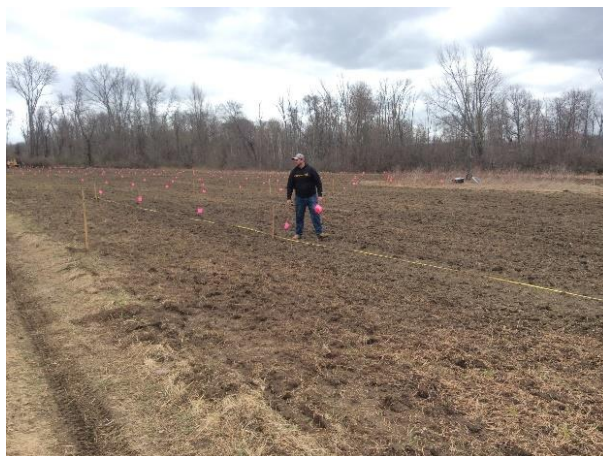
Figure 5: Diking results and planting design, spring 2018

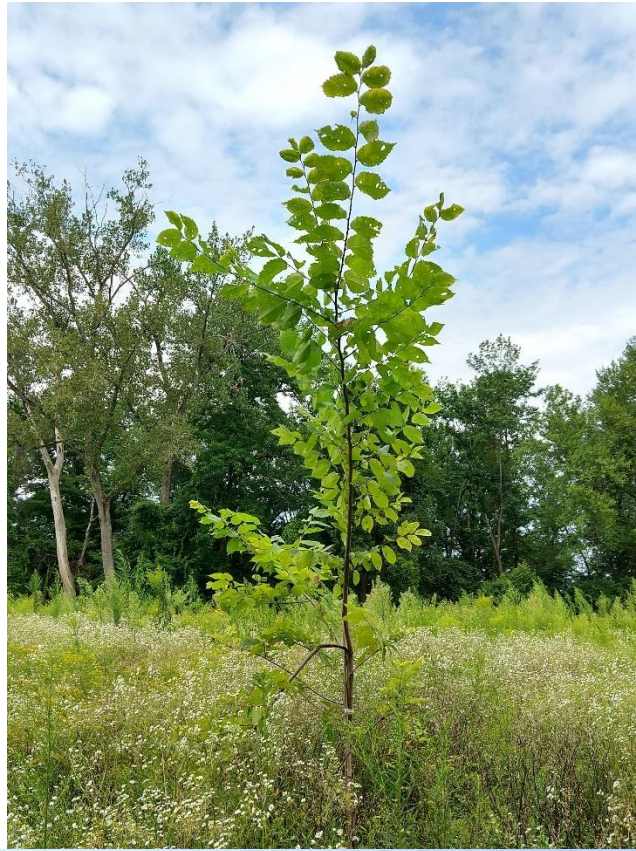
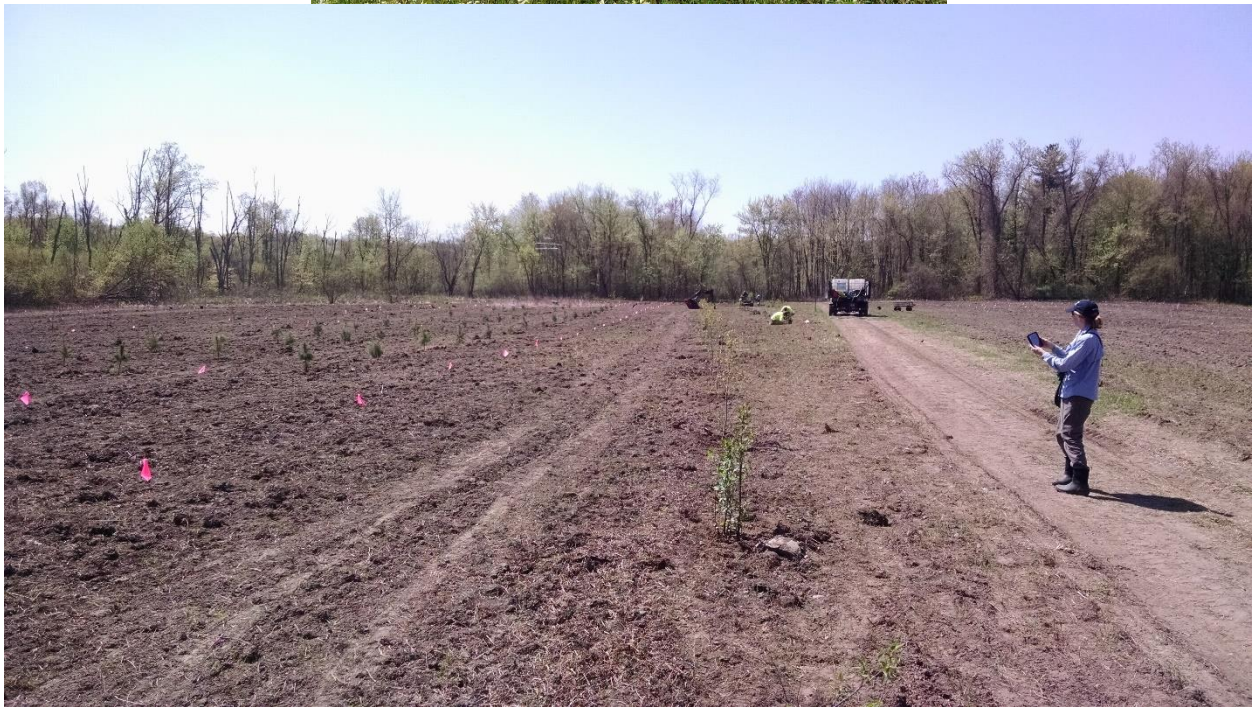
Figure 6: Tree Planting 2018; top photo is of disease resistant American elm

Ninety-four disease resistant American Elms were included in the plantings (Figure 6; Appendix B). The elms that were planted at Fannie Stebbins Wildlife Refuge were cloned from cuttings that came from trees that have demonstrated high levels of tolerance to Dutch elm disease in rigorous inoculation tests. All of these elm selections are native to northeastern North America (i.e. they are pure *Ulmus americana*). The elm selections that we planted include the following selections: “Valley Forge”, “Princeton”, “Saint Croix”, “Prairie Expedition”, “R18-2”, and “Delaware-2” (Haugen & Bentz 2017). More details on locations and monitoring are in Appendix B.

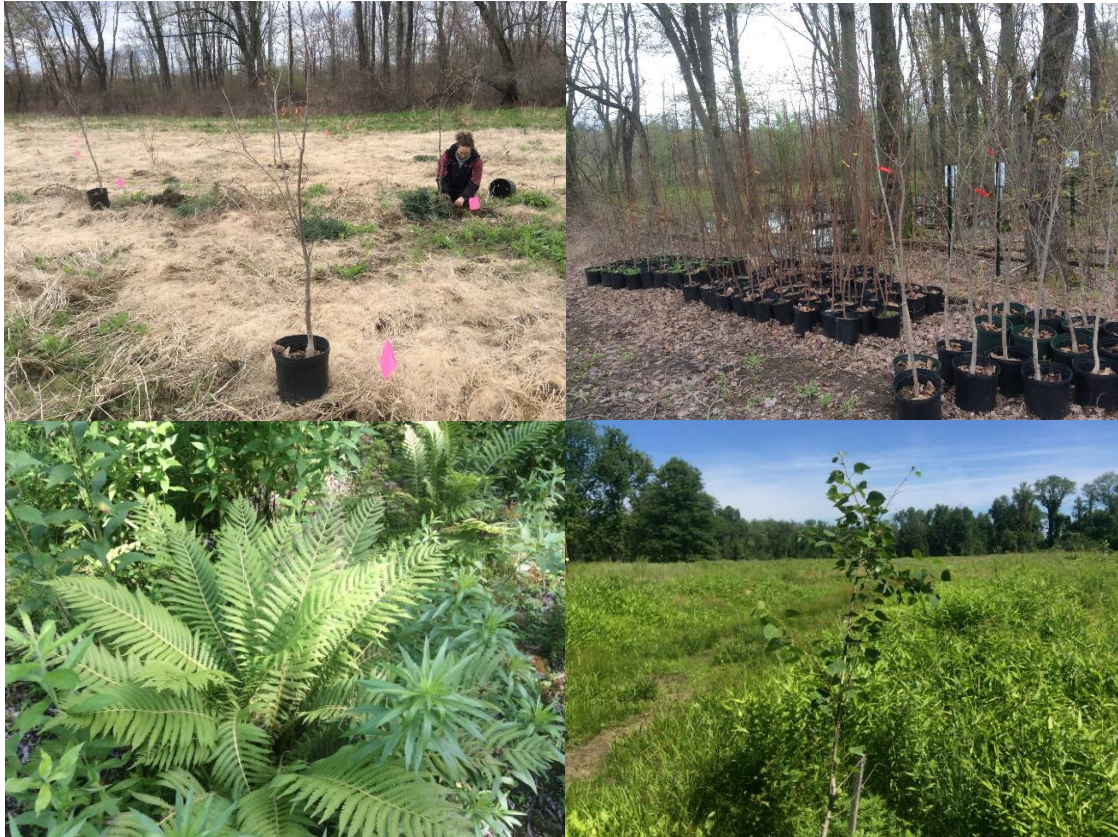
Figure 7: Plantings 2019

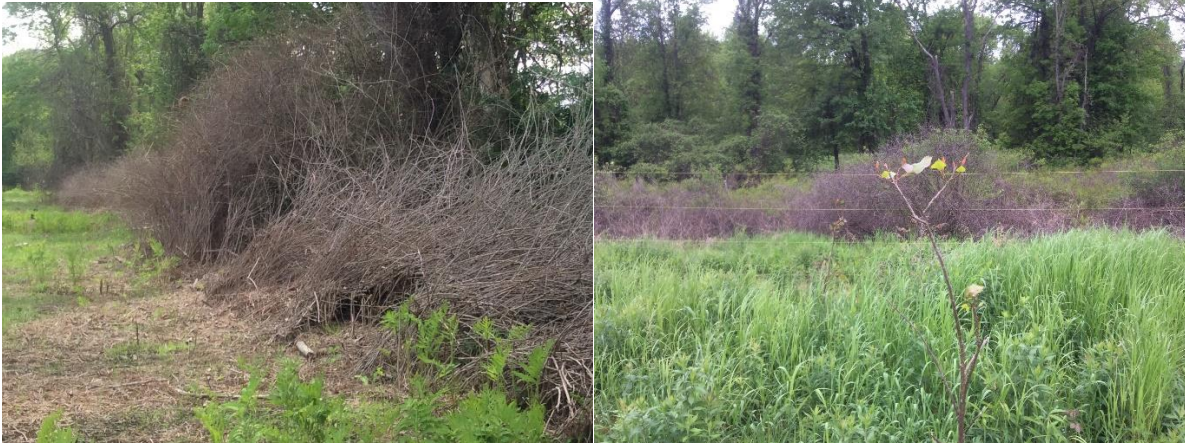
Figure 9: example of invasive shrub control on field edge

Smaller diameter (under two inches) and multi-stem tree, shrub, vine and other woody species like Asiatic Bittersweet, autumn olive, glossy buckthorn, Japanese barberry, multiflora rose, Norway maple, porcelain berry, privets, shrub honeysuckles, tree-of-heaven, wine berry, winged euonymus, etc. were

managed using a thin invert emulsion foliar application of a tank mix of herbicides with the active ingredients Imazpyr, such as Polaris®, Glyphosate, such as Rodeo®, and Metsulfuron methyl, such as Escort XP®. These herbicides were selectively applied using backpack sprayers to avoid non-target injury to the native plants.

The larger diameter (over two inches) tree, shrub and vine species like Asian bittersweet, autumn olive, glossy buckthorn, Norway maple and tree-of-heaven were controlled using basal bark applications of an herbicide with the active ingredient Triclopyr BEE, such as Garlon4®, mixed in a methylated seed oil carrier. This herbicide penetrated the bark and translocated throughout the plant, killing the root system. This application was conducted using a low-volume backpack sprayer to wet the entire circumference of the bottom 12 inches of the stem.

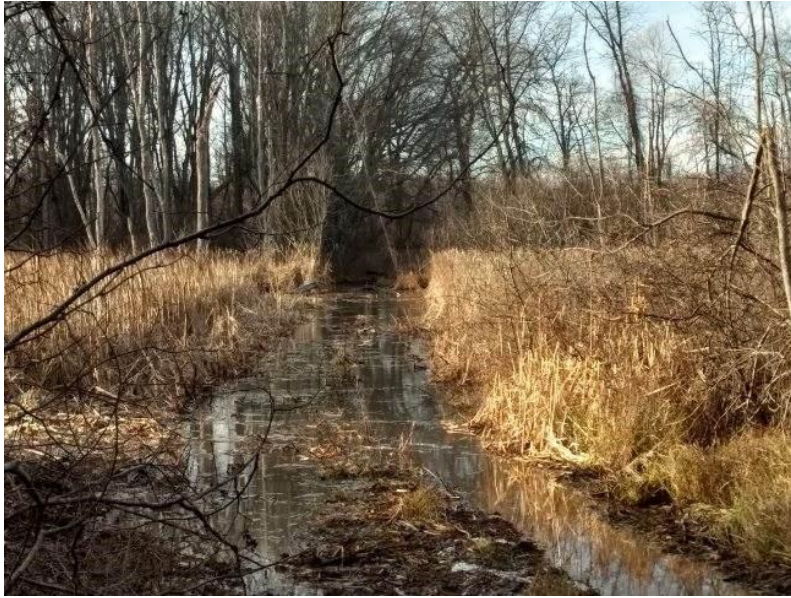
Figure 10: area of berm removal (post removal during high water)

The berm removal was completed in November 2019 and included removing 500 ft of the old Meadow road where it crossed several swale wetlands south of the eastern most field near Rt 91 (Figure 10). This included removal of roughly 74 cubic yards of material along 500 linear feet of an old roadbed. The profile cuts were based on engineering profile outlays and showed four critical cuts to return proper flow. The contractors used a handheld GPS to find the proposed cut grade sections. Once the sections were marked out, they staked and flagged the areas. As the digging was performed, they used a laser level to find elevations to match the cut profiles. The area was under an unusually high amount of water as a result of the heavy rains that season. They were able to match the profile cuts using the stadia rod and laser level to ensure the elevations all matched.

In the process of making these cuts, the removed soil was evenly spread along the “proposed excavated material on-site spreading area” along the eastern edge of the berm. The contractors removed roughly three tons of concrete, which was hauled off and disposed of properly. They also removed and disposed of an old section of guiderail with 2 concrete anchors. The plans called for removing a 20-foot section of old PVC pipe, but they were unable to locate and remove the pipe.

- Entire removal of the berm was very challenging due to high water, crumbling bituminous pavement and loose material. This project should not have been left until the end of the project period when contingency plans were not possible.
- The contractor suggested more interaction between partners on this portion of the project earlier in process; for example, they did not know NRCS needed to do inspection as it was not included in contract.

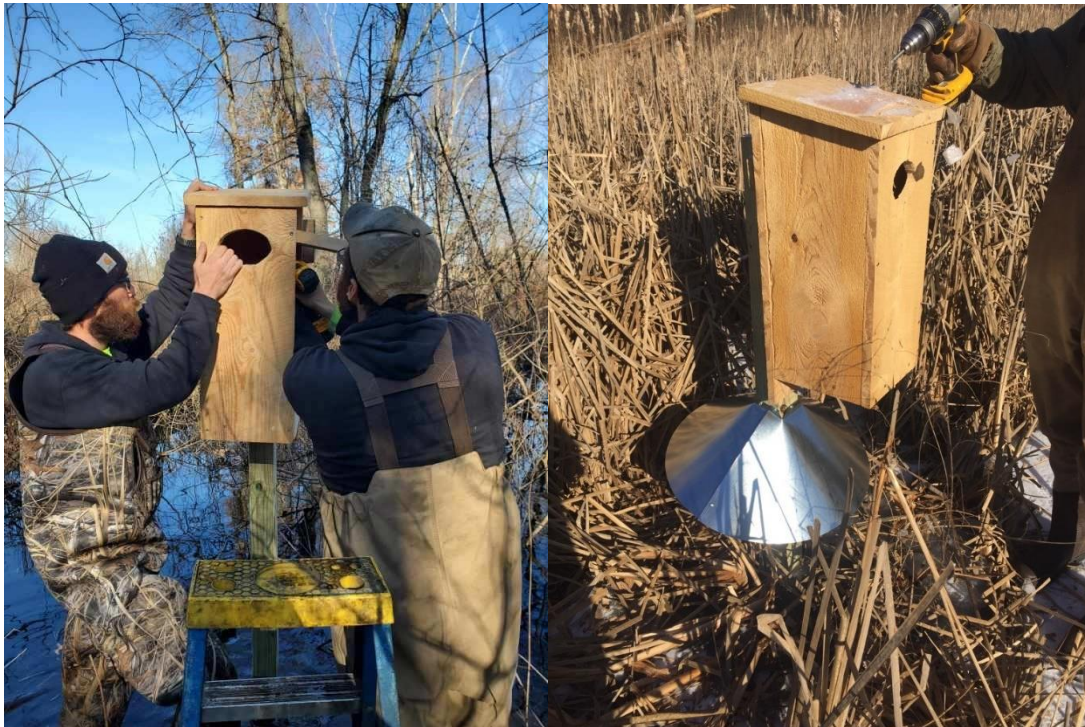
Figure 11: Wood duck nest box installation (photo credit: All Habitat Services)

Twenty wood duck nest boxes with predator guards were placed in or adjacent to wetlands (Figure 11) One osprey nest platform was placed in the wetland east of the Pondsides Rd field (Figure 12). Locations are indicated in Figure 13.

- Placement/layout of wood duck boxes could be improved in the future; some are now flooded and one is already missing as it was too close to a trail. A high-resolution digital elevation model could be combined with flood records for the site to predict typical flooding depths in locations for wildlife structures.
- The turtle nesting mound may not have been all that critical as there is lots of turtle habitat at site and mounds can attract predators. The bid that came in was not adequate to complete a nesting mound, so it was not constructed. It would have been helpful to discuss this idea with Division of Fish and Game during the planning phase to determine the value of creating turtle nesting habitat.

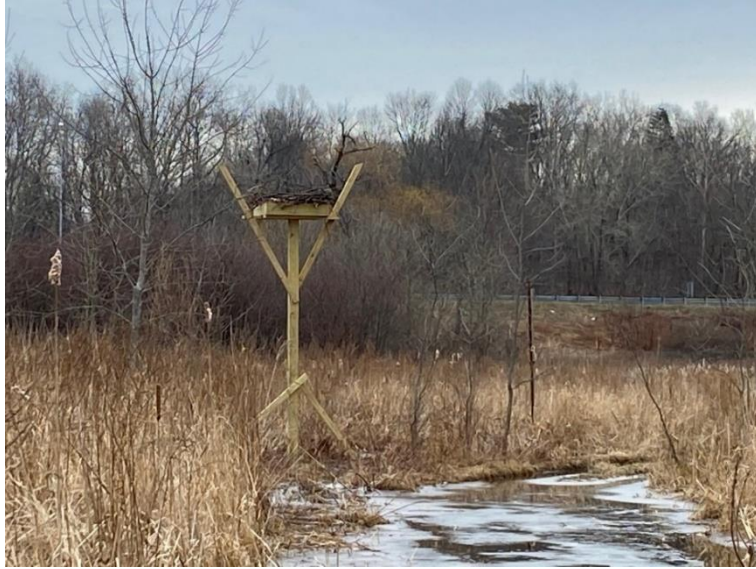
Figure 12: Osprey nest platform

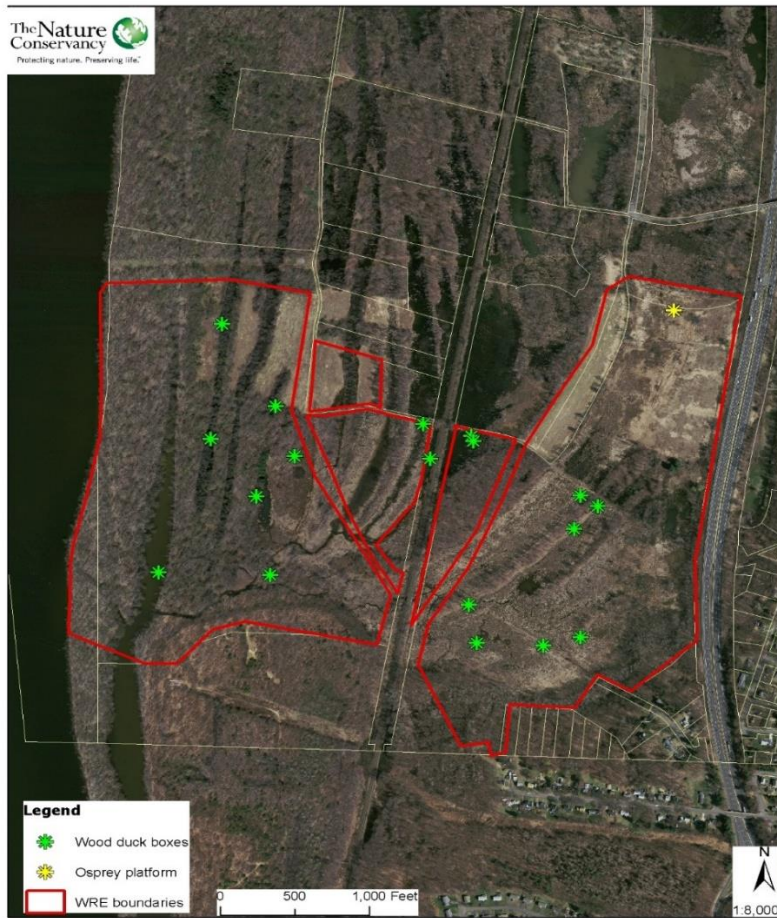
Figure 13. Locations of installed wildlife structures including wood duck nest boxes and an osprey nest platform.

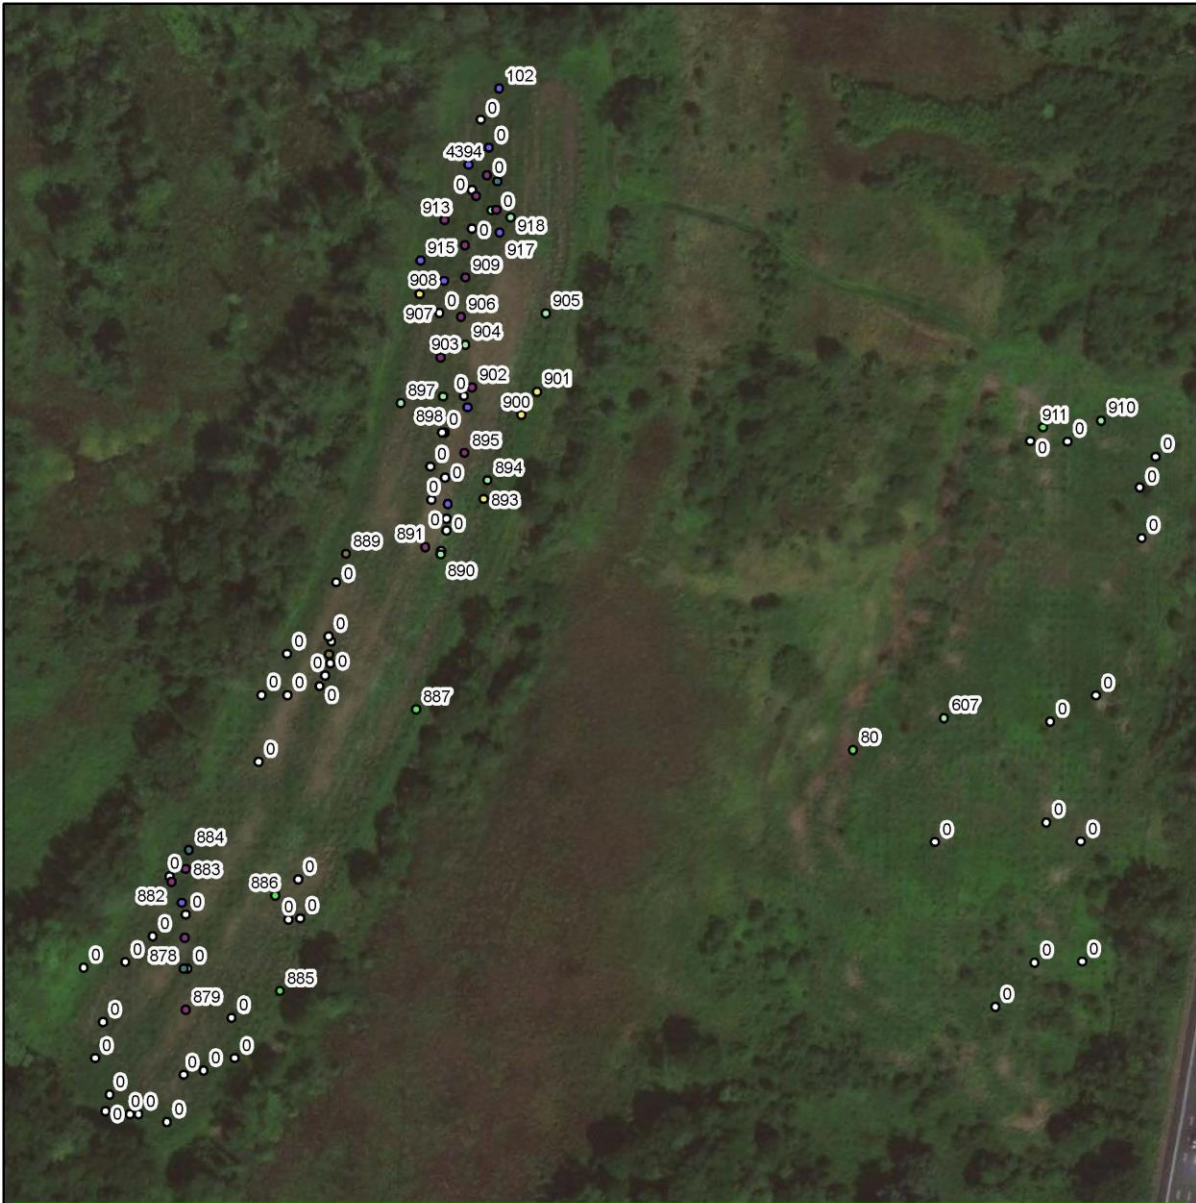
Fannie Stebbins Wildlife Refuge East

The maps below show the locations of disease tolerant elms that survived in the initial years after planting as of spring 2020. All of these elms are native selections of *Ulmus americana*. The planted elm include the following disease tolerant varieties: Princeton (PRN), Valley Forge (VF), Saint Croix (SC), Prairie Expedition (PE), R18-2 (R18-2), and Delaware-2 (DEL-2), as well as some new varieties whose level of disease tolerance is still untested. Although the smaller elms suffered from deer browse in the first weeks after planting, they were subsequently protected by an electric fence. Most elm seedlings have now recovered from the initial deer browse or antler rub damage and have started growing quickly. The elms labelled with tags in spring 2020 and lower side branches were pruned off. Unlike other planted trees at the refuge, the elms have plastic tree wrap around their stems to protect against girdling of the bark by rodents. This tree wrap will need to get removed in two or three years when it becomes tight around the stem as the trees continue to grow in girth. An ArcGIS shape file version of the elm monitoring map is available from Gus Goodwin of TNC's Vermont field office. We recommend using the ArcGIS on-line map and the collector App for future monitoring of elm growth and survival. The ArcGIS on-line map includes additional monitoring data such as tree heights and tag numbers. In spring 2020, elm saplings were between 0.3 and 4.3 meters tall. Monitoring is easiest in May before the herbaceous vegetation in the old fields gets tall because it makes finding the elms much easier. Elms should get monitored at least once every second year until the trunks are over 3 cm diameter and the tree wrap has been removed.
