Sal Creek Restoration Project

Prince of Wales Island, Alaska

Stream Ecosystem Restoration

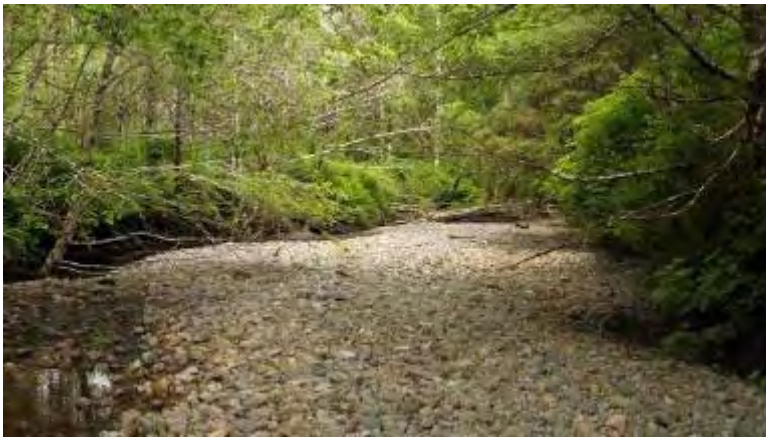
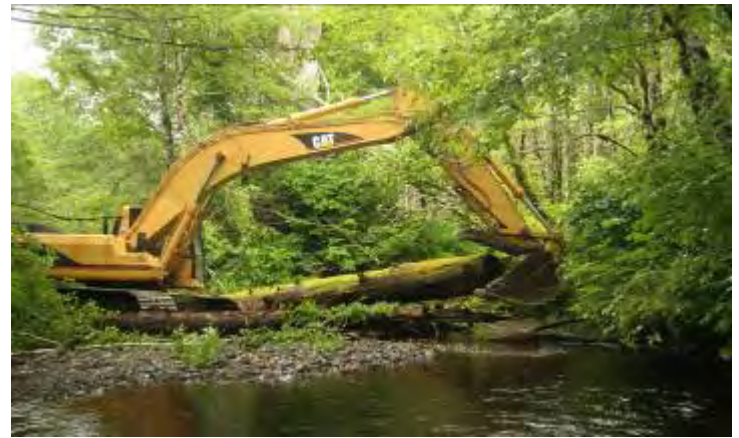
Before restoration, the above portion of Sal Creek was shallow and had no big logs to create deep pools. On the right, a hemlock tree was used to build a log jam to create a more complex habitat. Today, this portion of Sal Creek is deeper, its banks are protected, and deeper pools offer fish habitat. Photos: USFS

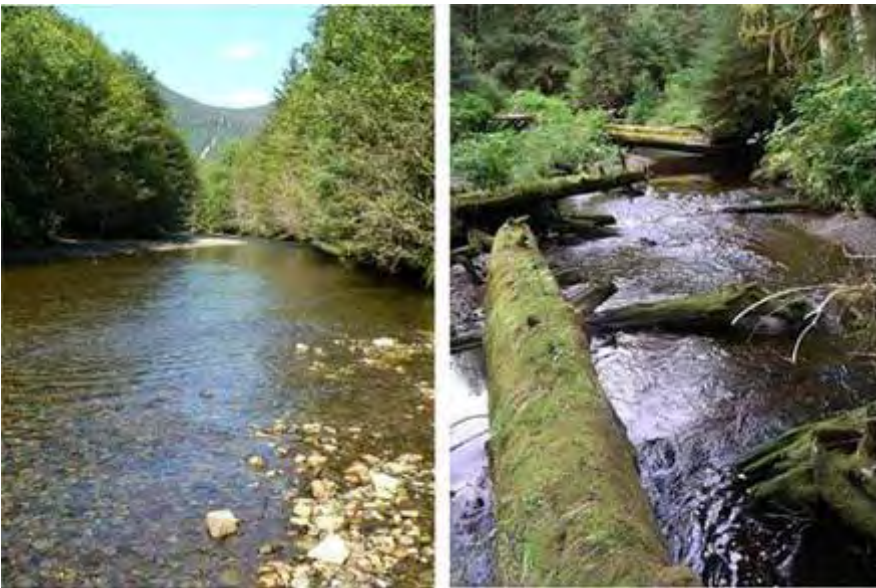
Historical practices such as logging riparian forests led to impaired stream function and reduced diversity of habitat, as in the photo at left. Fallen logs and woody debris, right, create large pools, undercut banks and other cover that provides high quality habitat for salmon. Photos: Scott D. Tiegs

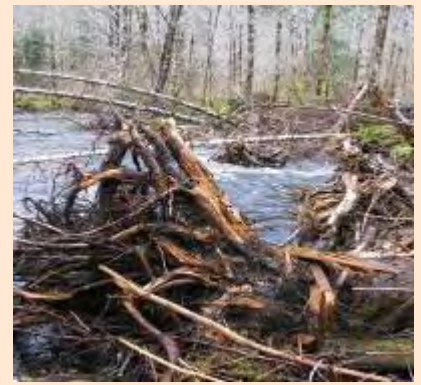
These root wads were placed in the stream channel to stabilize the stream bank and improve fish habitat. Photo: USFS
