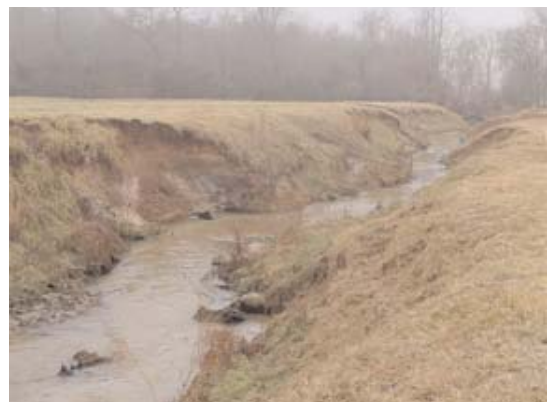
This Etowah tributary was straightened in the past to prevent flooding of the surrounding property. The landowner says the stream channel was knee-high when he was a kid. Subsequent erosion has deepened the channel significantly.

Drainage districts were formed across the state in the early 1900s in an effort to reclaim many of these areas. Contrary to current philosophies of stream management, many miles of waterways were channelized across Georgia during this period. While such activities may have been a short-term solution to flooding problems, they likely accelerated the long-

term erosion of stream channels and delivery of sediment to downstream areas.
