LIVING SHORELINES

# Taylor's Riverview Park

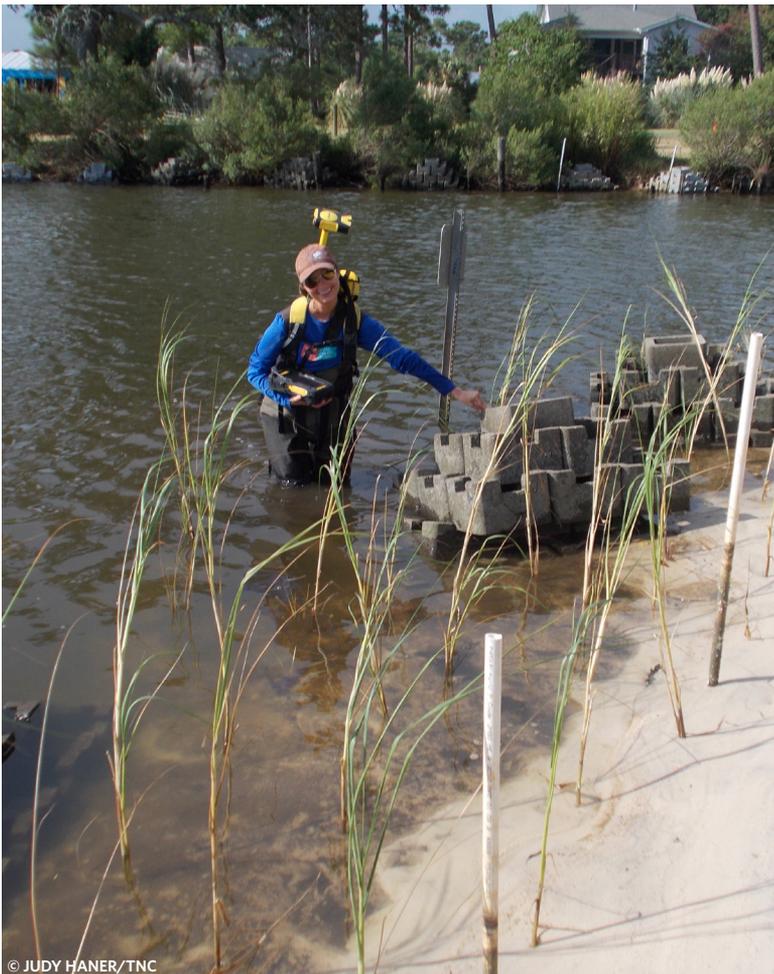
Shoreline monitoring after installation of marsh plants.

park had experienced erosion from recreational boating wakes. Prior to construction, large pieces of concrete used to armor the shoreline were removed. The concrete had degraded the nearshore habitat and promoted the establishment of invasive species. Following construction of the reefs, *Spartina alterniflora* was planted on the shore to stabilize the sediment. This project was built with the help of 27 volunteers putting in 155.5 hours. The marsh grass has shown steady growth and expansion and now is actually covering some of the reefs.
