Goose Creek – BlueWildlife LLC (PO-5)

Fauquier County, Virginia

BlueWildlife Mitigation Activities

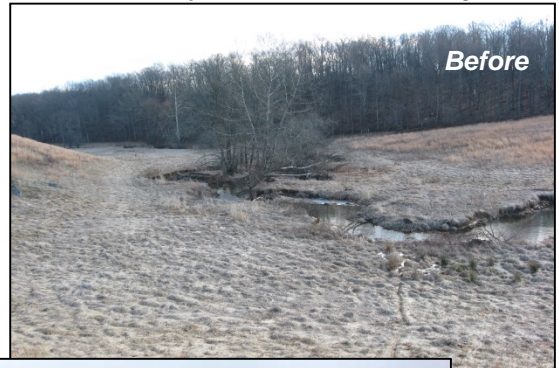
Before: Cattle had access to streams, streams were incised and degraded, and adjacent wetlands were impacted.

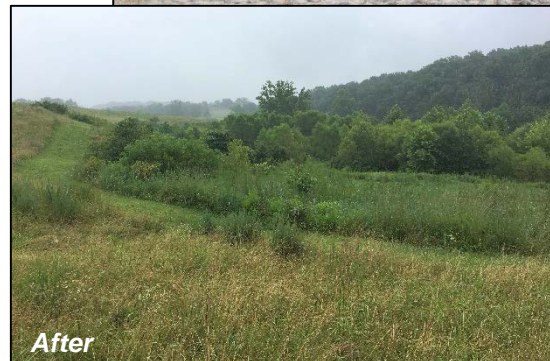
After: Livestock removed, stream channels re-connected to the floodplain, wetlands created and enhanced, and riparian buffer restored.

Restoration work began in 2009 and entailed removal of livestock, reducing the steep height of the stream banks, realigning the stream channel, adding meanders and in-stream habitat structures, creating wetland depressions and open water features, and planting trees to create a forested buffer along the stream and to enhance existing wetlands.

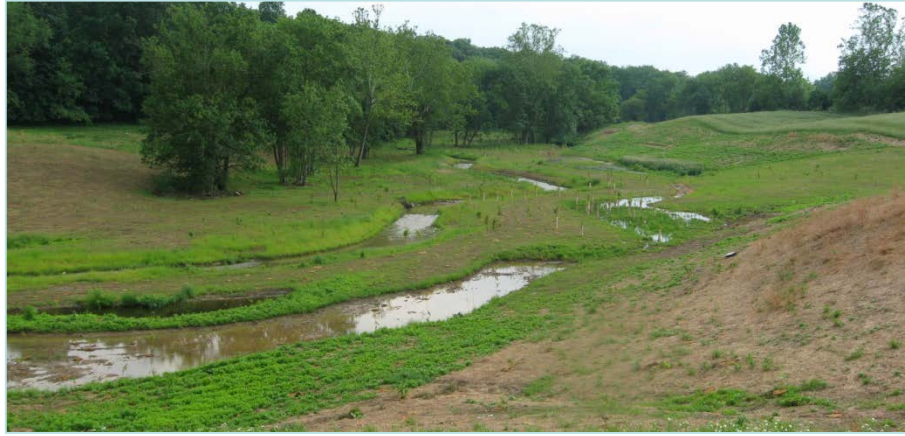
A total of 58 in-stream grade control and habitat structures were installed. Abandoned channels were left in place and were designed to receive overbank flow, creating oxbows. Although not a mitigation activity, these open water features create habitat for waterfowl, a component the property owner was seeking.

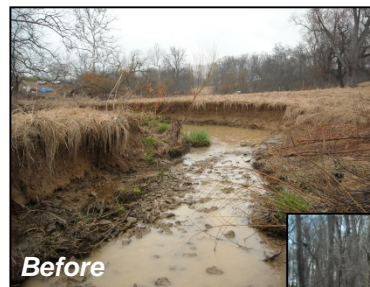
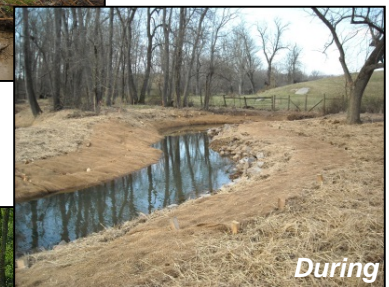
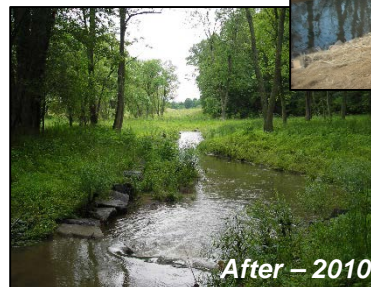
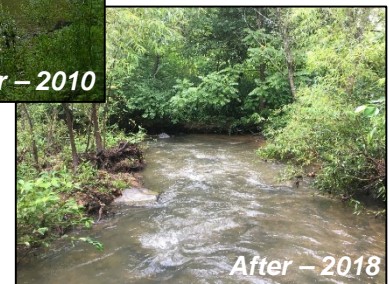
Maintenance activities along Bolling Branch to repair minor bank scours and stabilize structures following large storm events.

Control of non-native/invasive plants. Species treated include reed canary grass, cattail, quackgrass, burdock, cocklebur, garlic mustard, jimsonweed, teasel, velvetleaf, wormwood, autumn olive, rambler rose, beefsteak plant, tall fescue, poison hemlock, privet, Japanese barberry, tree-of-heaven, princess tree, and non-native thistles, docks and honeysuckles.

Beaver activity was observed in Bolling Branch following restoration. Monitoring for beaver was regularly conducted by USDA. Trapping and dam removal occurred on several occasions.
