## Ochoa Fertilizer Co. Guánica, PR

# **EPA NPL Listing Process**

## **Map:** Ochoa Fertilizer Co. Guánica

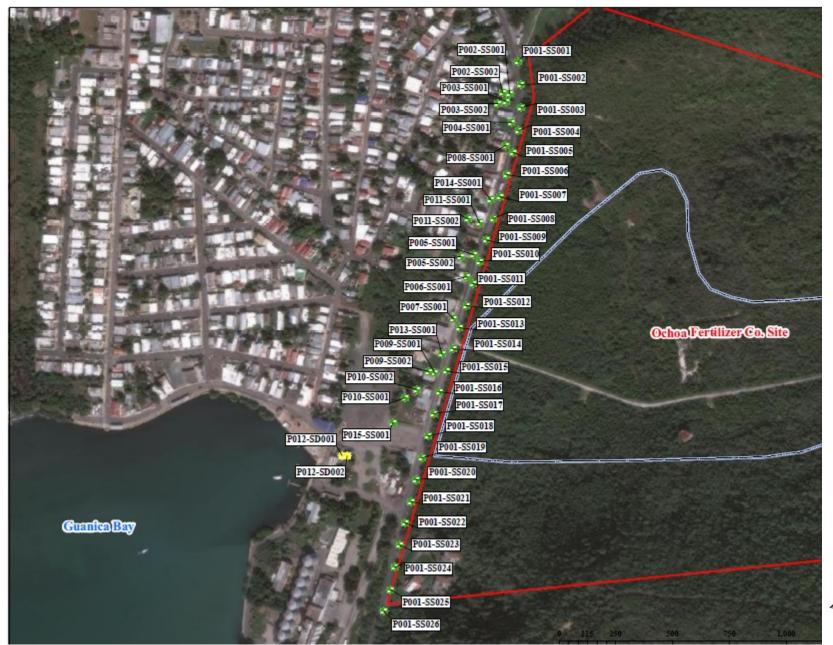
#### SAMPLING PLAN

- May 2021: soil sampling to evaluate potential overland flow of PCBs from the site proper to residences and impact to town's pumping station.
- 48 surface (0-2") soil samples from 14 properties on both sides of PR-333

- Aroclor-1260 detected at all sampling locations (screening level 1.0 ppm)
  - 26 locations on the right-of-way on eastern side (considered as one property)

- Arcolor-1260 >1ppm at 12 of 26 locations, ranging from 1.0 J to 55 ppm
  - 19 locations on 13 properties on the western side:
    - One (1) commercial property, in front of abandoned gas station (2 locations): 6 ppm

- **12 residential properties**; Arcolor-1260 >1ppm at 4 of 12 residences, ranging from 1.1-6.0 ppm
      - Five (5) for which we have signed access forms (2 locations/property, 10 total) two >1ppm

- Six (6) rights-of-way in front of residential properties (1-2 locations/property) one >1ppm
      - One (1) open residential lot (2 locations) 4.8 J 5.2 J ppm

- Sediment from pump station contained <1ppm Aroclor-1260 and Aroclor-1242</li>
