# New York City Oyster Monitoring Report

2018

The Nature  
Conservancy

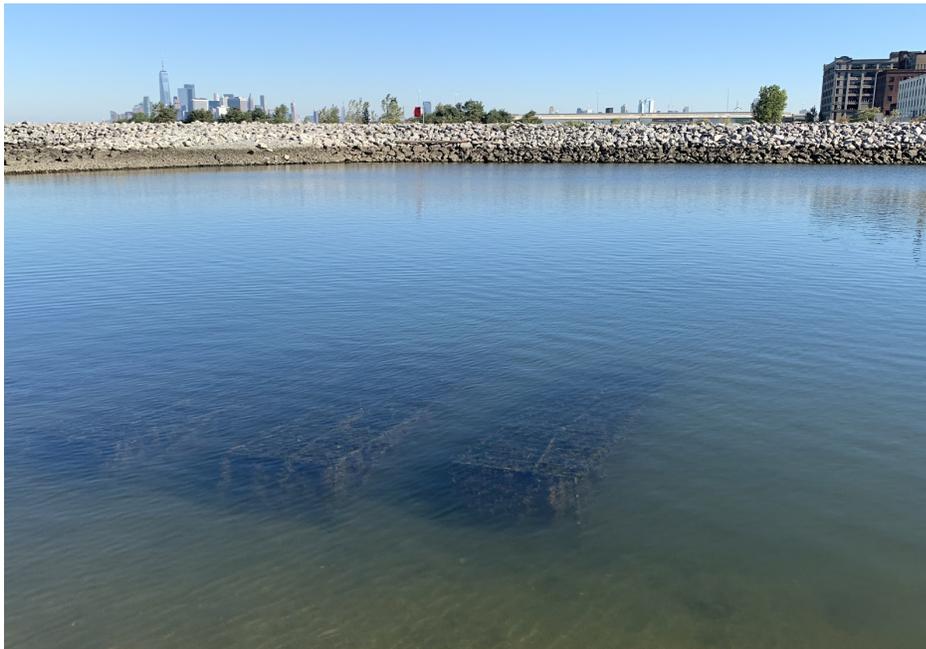
**Figure 2.** Cabinets were installed at the Sunset Park Community Reef in Bush Terminal Park, Brooklyn.

A variety of different restoration approaches and structures were used, depending on unique site conditions, project objectives, and our continually developing understanding of best practices for oyster restoration in these waters. Community reefs are welded, steel rebar structures that hold cages of oysters off the bottom (Fig. 1D). These structures allow the cages to be removed for monitoring above the water surface. The term “nursery” describes restoration sites where oysters are held off the bottom in floating or suspended structures, regardless of the size or age of the oysters. Nursery gear types include OysterGros® (Fig. 1C) and Super Trays (Fig. 1F), both of which are used in commercial aquaculture. 2018 was the first year in which several restoration approaches were tested, including bagged shell reefs (Fig. 1A) and EConcrete® discs (Fig. 1E). Smaller versions of gabions (Fig. 1B) that have been piloted at the Hudson Reefs near the Mario Cuomo Bridge (formerly the Tappan Zee Bridge) were used at Lemon Creek Lagoon.

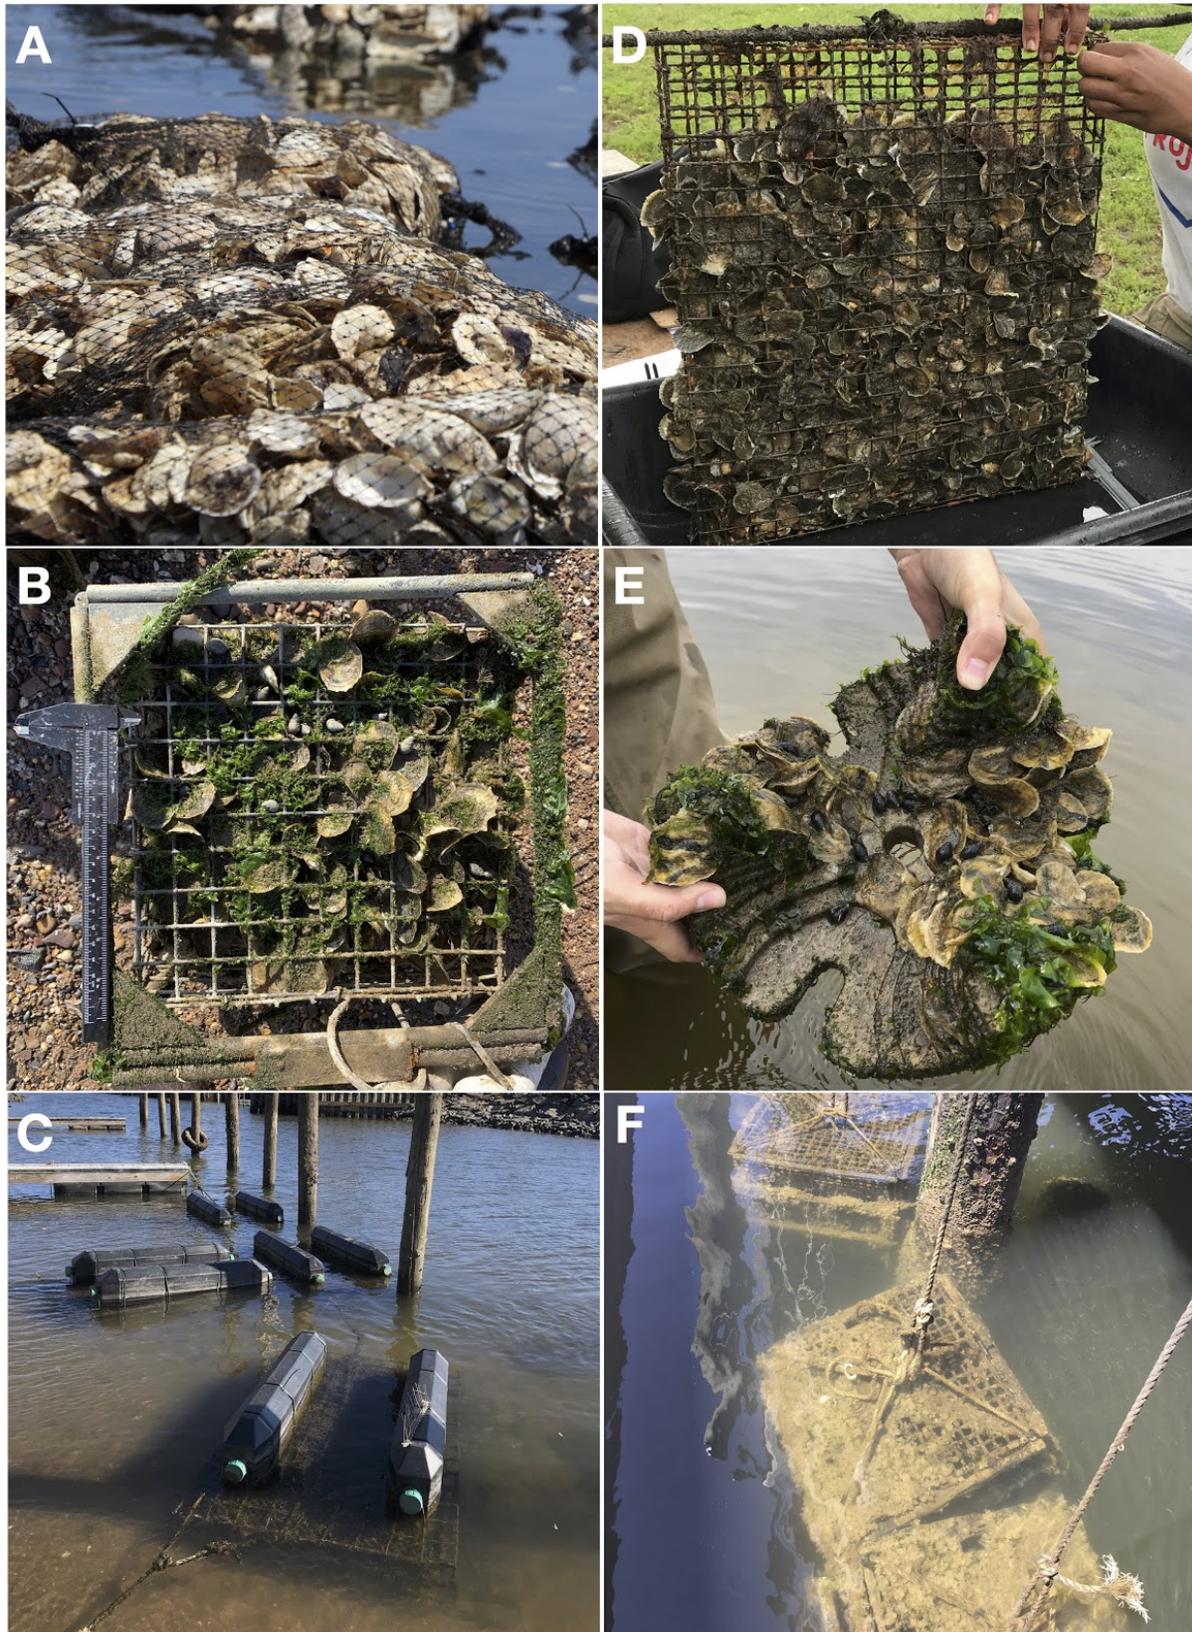
**Figure 4.** Examples of structures employed to install oysters: (A) bags, (B) gabions, (C) OysterGros®, (D) community reef files, (E) EConcrete® discs, and (F) Super Trays.

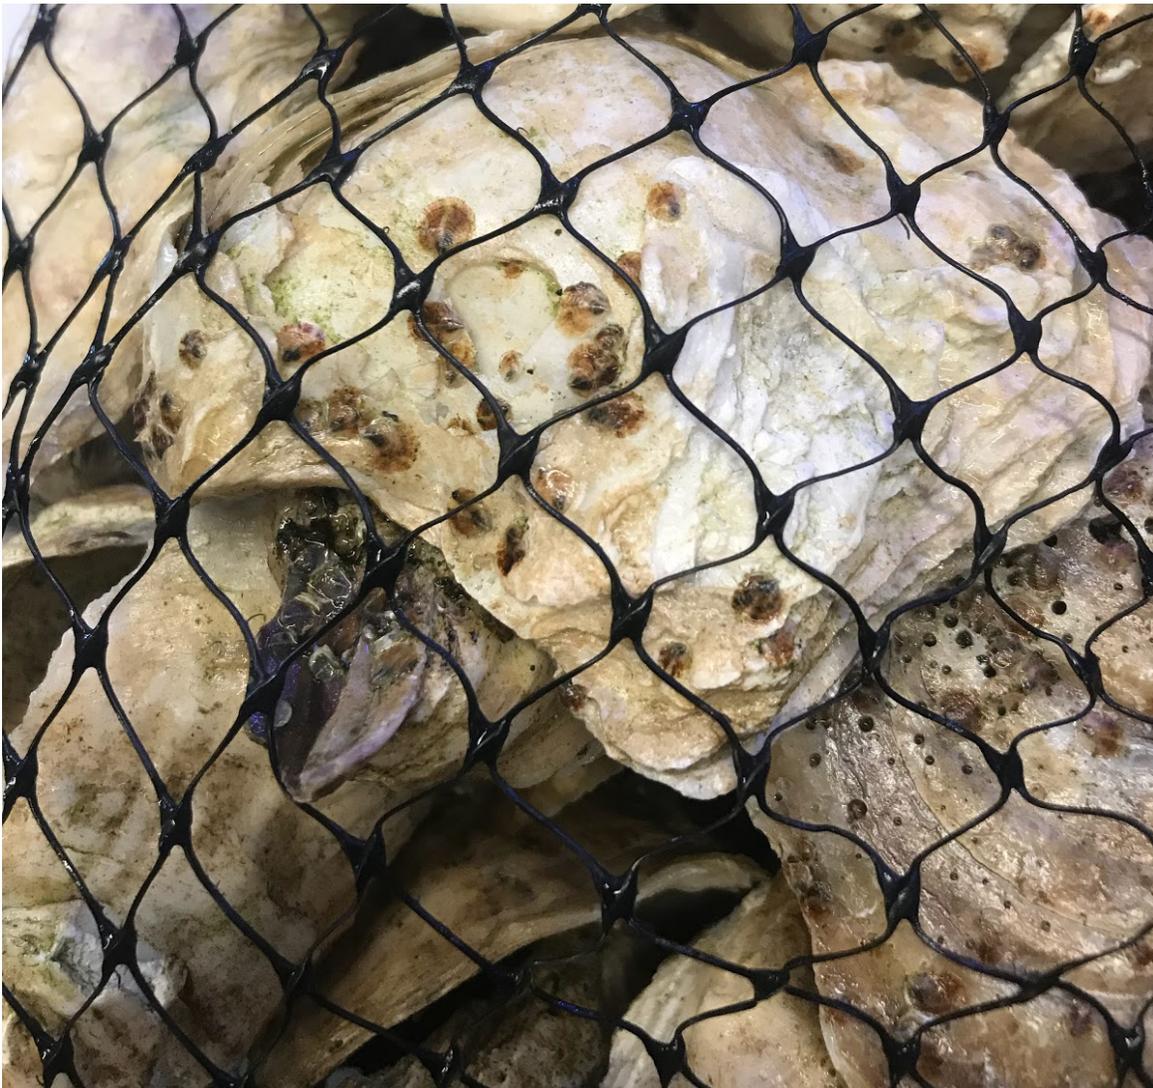
**Figure 5.** This spat-on-shell was set at the BOP hatchery on Governors Island.

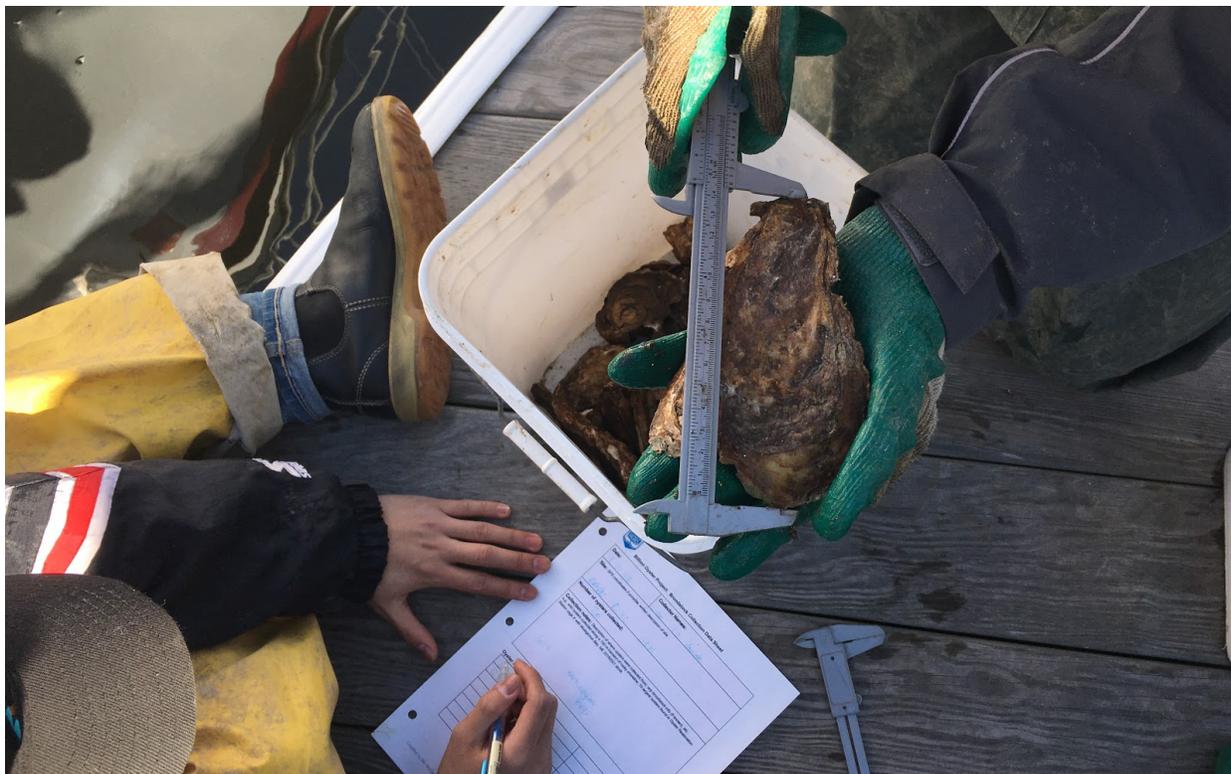
**Figure 8.** Field technicians measure oyster growth at Great Kills Harbor.

Oyster growth was quantified by measuring change in shell height through time. Shell heights were measured with calipers to the nearest millimeter (Fig. 8). Only the shell heights of live oysters were included in the analysis. The methods for measuring oyster shell height depended on the specifics of the oyster restoration structure and the nature of oyster growth. At some sites, oysters remained in loose clumps and could be separated from each other. At those sites, typically all the individuals in a clump were measured. This method was possible at all sites except for the Canarsie, Coney Island Creek, and Sunset Park Community Reefs and the Lemon Creek Lagoon gabions and EConcrete® discs.

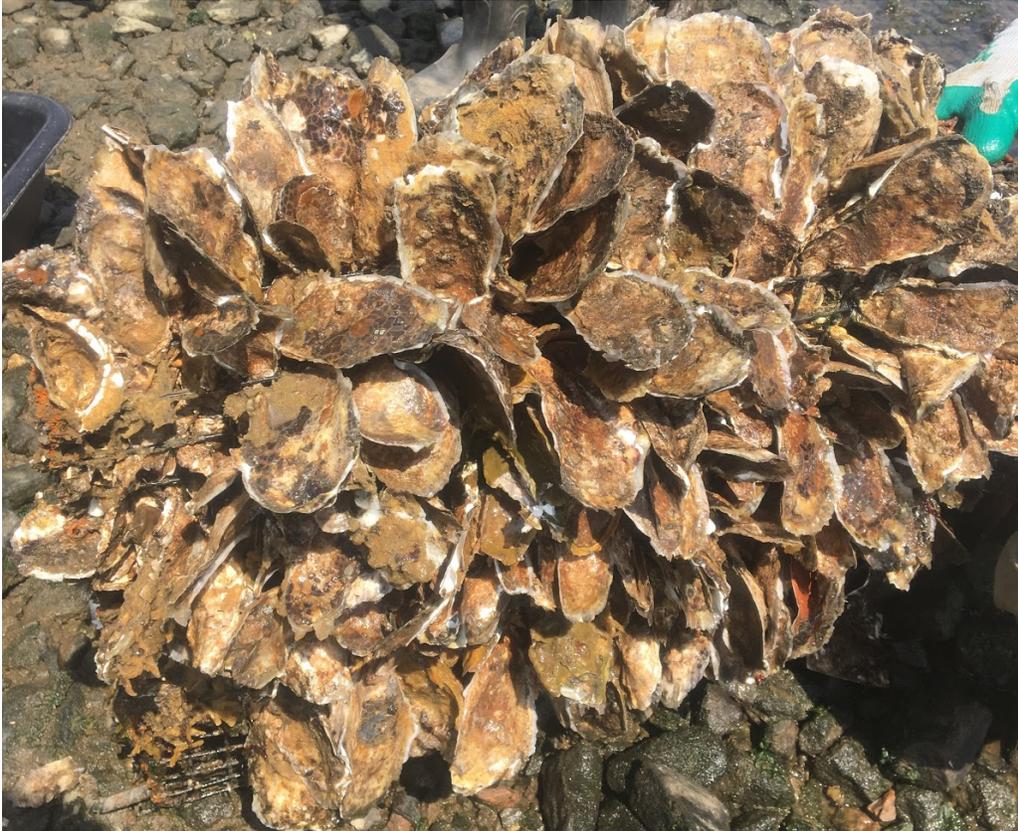
**Figure 12.** These oysters grew through the bottom of a community reef file at the Sunset Park Community Reef.

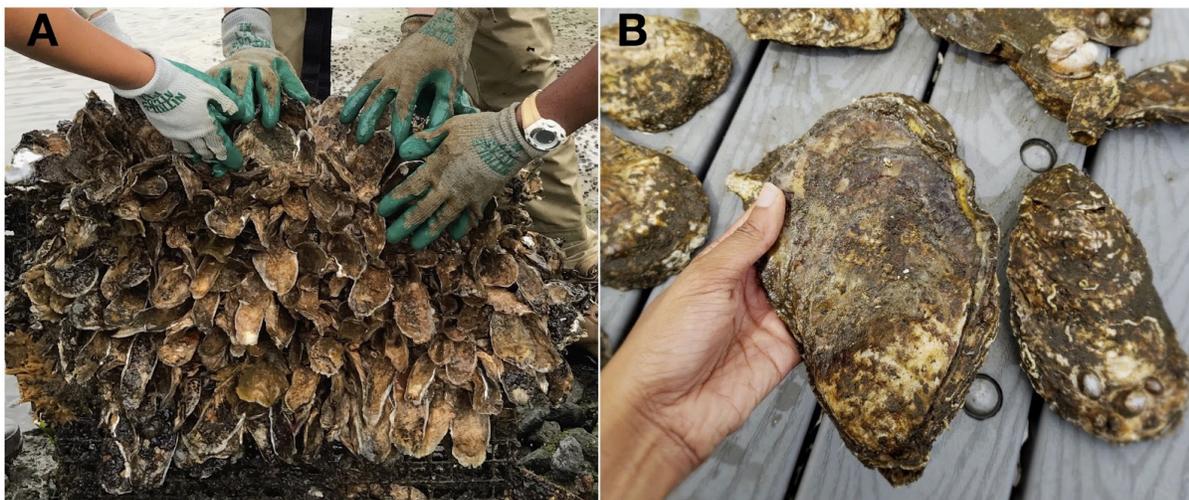
**Figure 27.** (A) Thinner morphology oysters growing through files at the Sunset Park Community Reef, and (B) thicker morphology oysters collected from an Oyster Research Station at the Canarsie Community Reef.

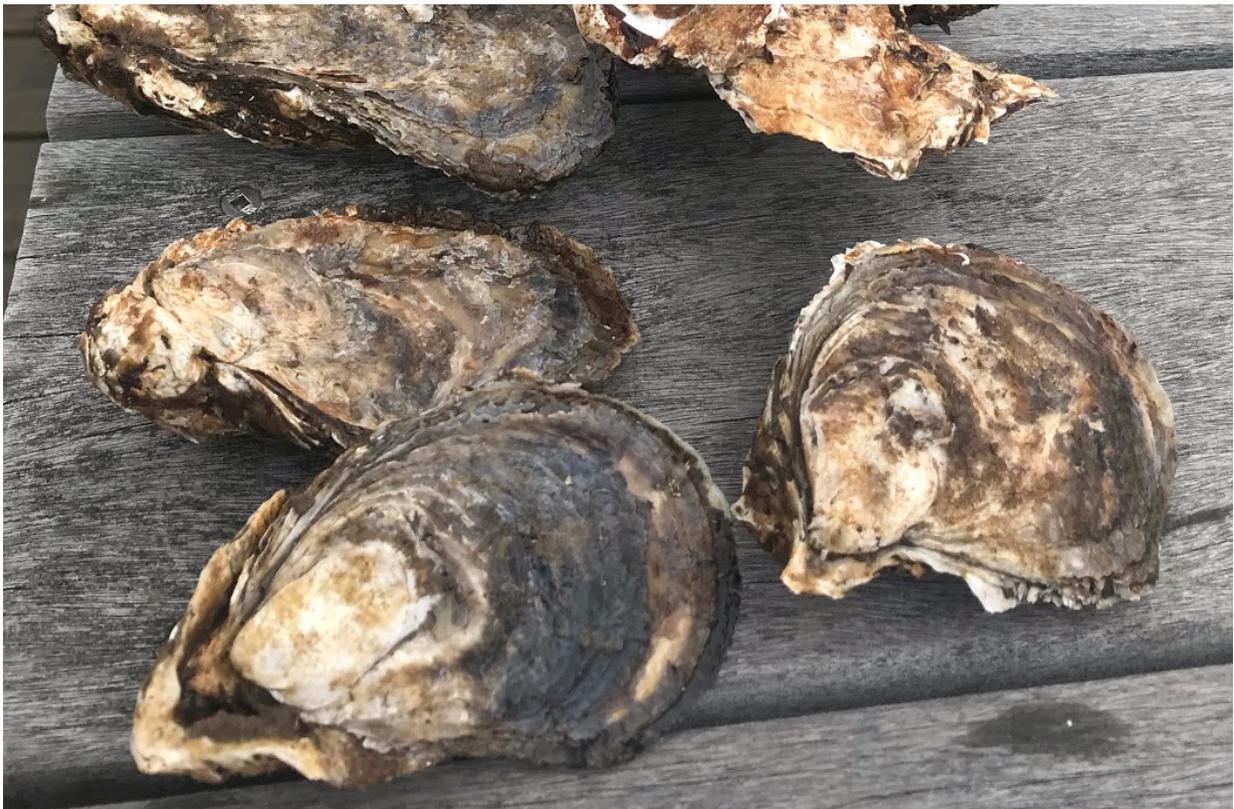
**Figure 29.** Adult oysters (installed in 2016) collected for disease and reproduction testing in October 2018 at Great Kills Harbor.

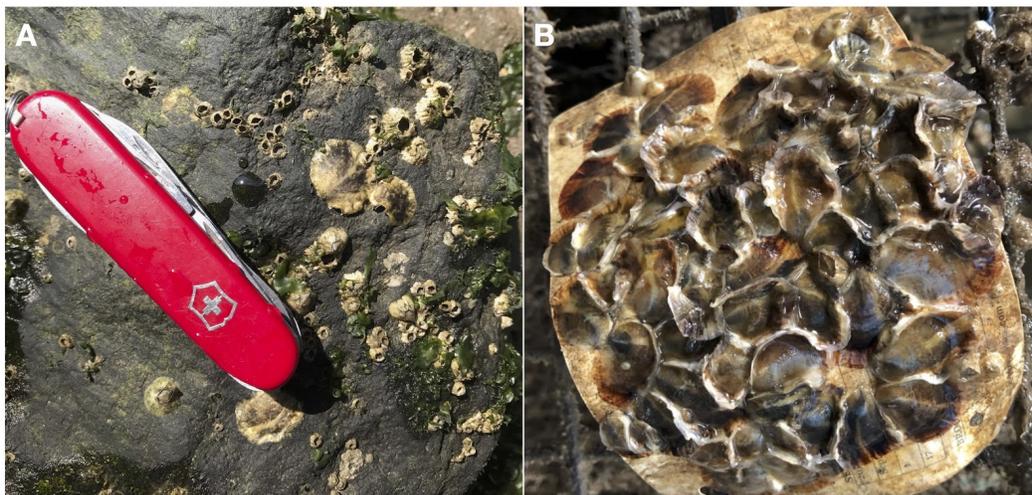
**Figure 30.** (A) Wild oyster recruits, along with barnacles and anemones, on intertidal rocks adjacent to the Coney Island Community Reef in summer 2018 (Swiss Army multitool for size comparison), and (B) wild oyster recruits seen at West Harlem Piers Park at 125th Street in Manhattan.

One of the performance metrics listed in Table 4 is “Spat on unseeded or off-reef structures.” The presence of juveniles or “recruits” is a positive sign for restoration (Fig. 30). Although there is no guarantee that the young oysters are the offspring of the oysters restored at that site, the presence of recruits is promising because it indicates that conditions are suitable for larval survival and transport at that site. For example, the juvenile oysters observed on intertidal rocks at Coney Island Creek were not the offspring of the oysters restored at that site, which were less than one year old and not reproductively mature. Regardless, their presence indicates that a source population is nearby and that conditions at the site are suitable for larvae.

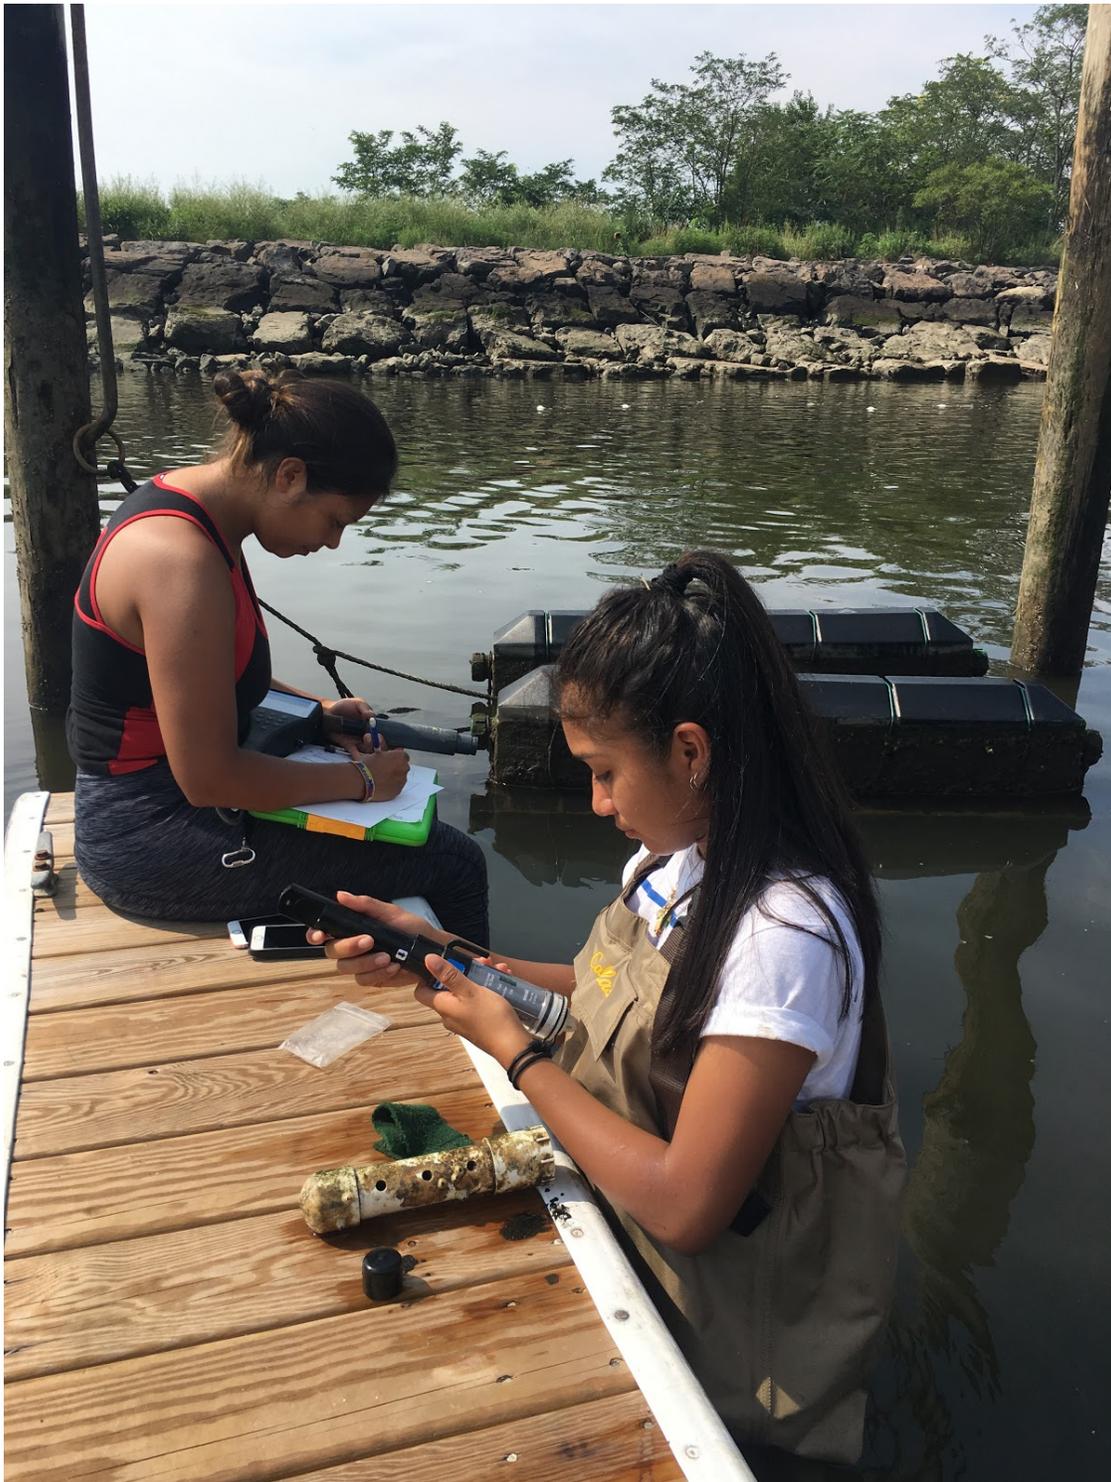
**Figure 32.** TNC Marine Science Technician Tatiana Castro-Gallego and BOP Summer Intern Lisette Mejia monitor water quality with HORIBA water quality meters and maintain HOBOLogger equipment.

On several sampling dates, point water quality data were measured using a Horiba U-52 multiparameter instrument (Fig. 32). This instrument measures temperature, dissolved oxygen, salinity, pH, conductivity, turbidity, and total dissolved solids. All samples were taken just below the water surface, adjacent to the restored oysters. Typically, three replicate samples, taken at least two minutes apart, were recorded on each sampling date. These samples only provide a snapshot of the water quality conditions at a site, and were typically taken in conjunction with the regular maintenance of water quality data loggers. (See *Continuous Water Quality Measurements* below.) The Horiba U-52 can also measure parameters not recorded by the water quality data loggers, such as pH and turbidity.

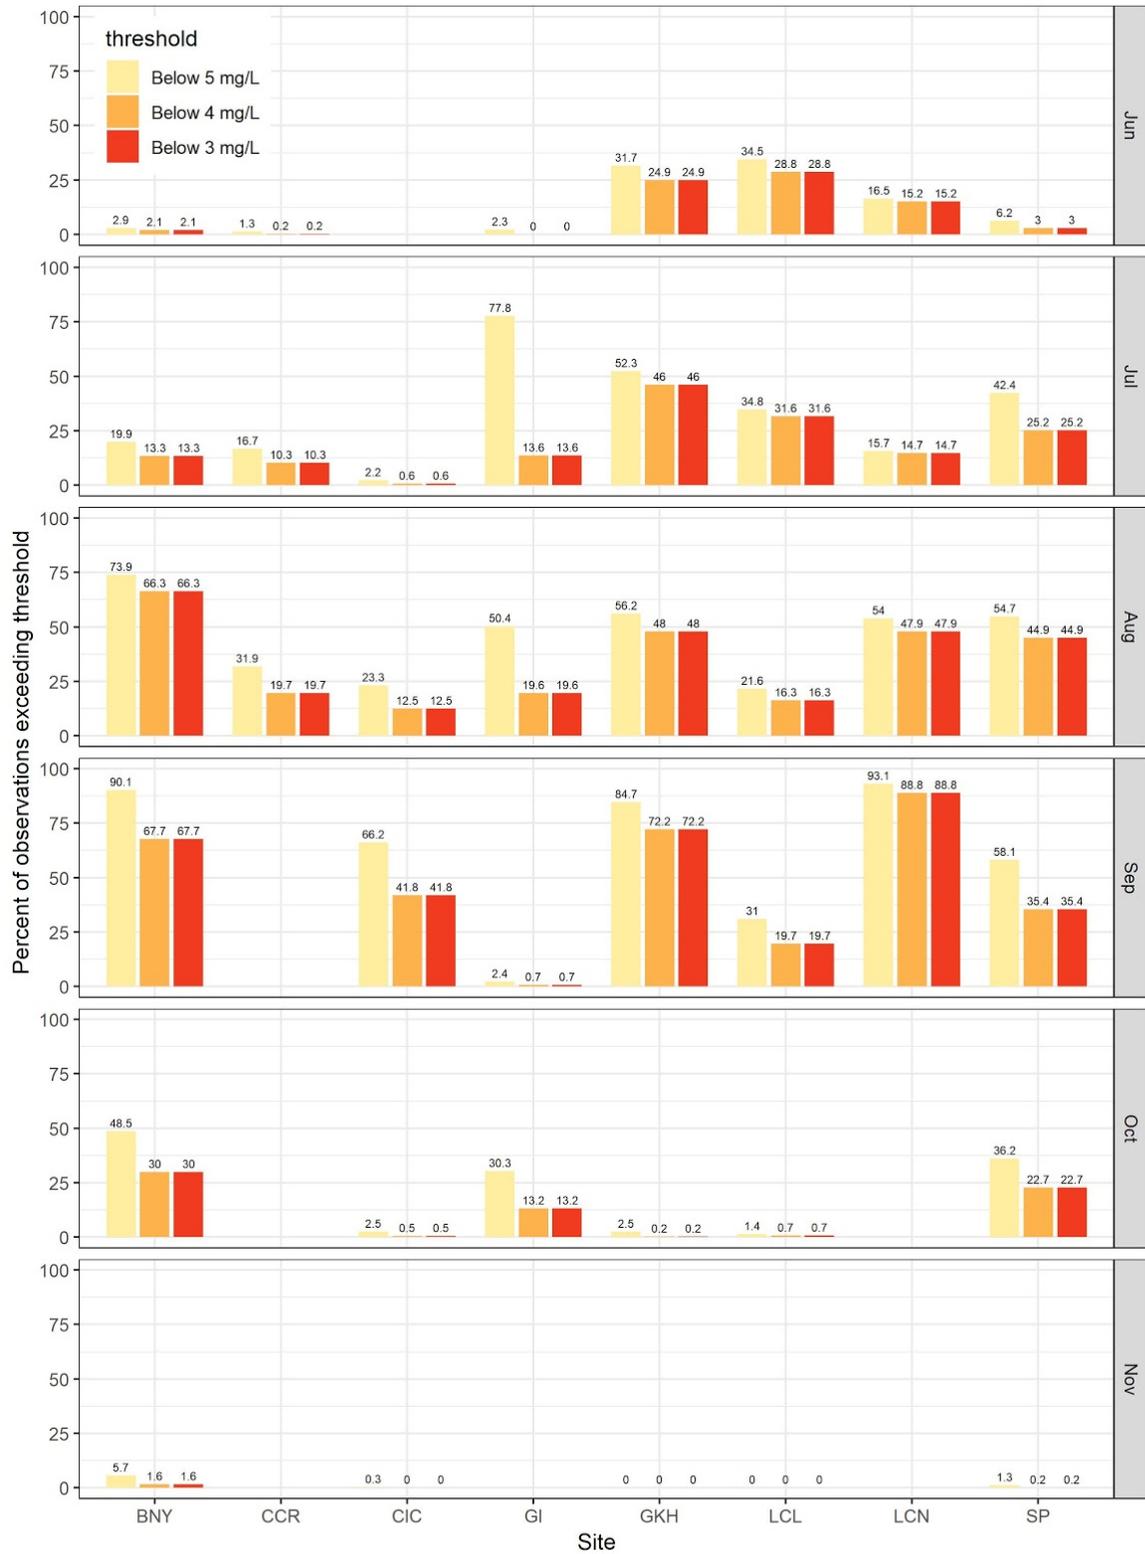
**Figure 38.** Percent of high-resolution (recorded every 15 minutes) dissolved oxygen measurements below 3, 4, and 5 mg/L in each month in 2018 for Brooklyn Navy Yard (BNY), Canarsie Community Reef (CCR), Coney Island Community Reef (CIC), Governors Island EcoDock (GI), Great Kills Harbor (GKH), Lemon Creek Lagoon (LCL), Lemon Creek Nursery (LCN), and Sunset Park Community Reef (SP).

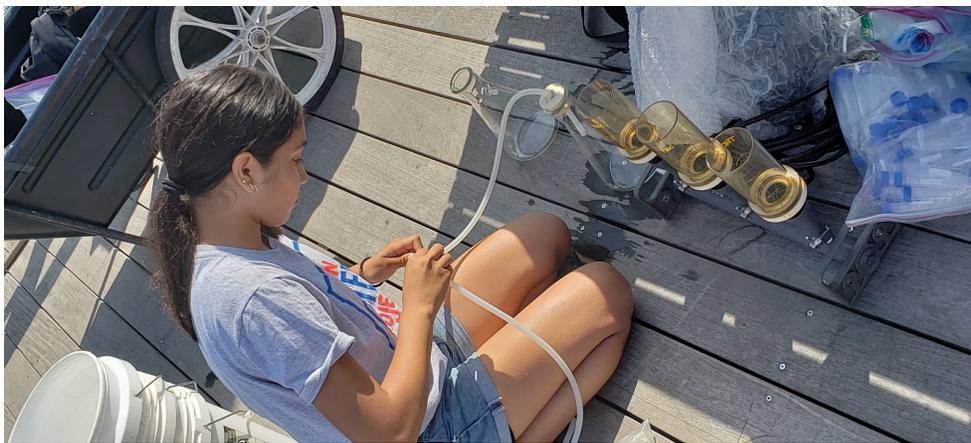
**Figure 40.** BOP Summer Research Intern Lisette Mejia sets up the vacuum filtration system to filter water samples for chlorophyll analysis.

At all sites, a known volume of water was filtered on a 0.7-micron glass fiber filter to measure all available chlorophyll *a*. Additional samples were fractionated between 5 and 20 microns to measure the chlorophyll *a* that is likely available to oysters (Newell & Langdon 1996; Fig. 40). Chlorophyll was extracted from the filters with 90% acetone and quantified via fluorometry with a Turner Designs AquaFluor handheld fluorometer in the BOP Hatchery on Governors Island. The chlorophyll *a* values were corrected via acidification to exclude phaeopigments. On each sampling date, three water samples for each filter size were analyzed to quantify variation. This sampling and analysis protocol was identical to the methods used in 2017. Each site was sampled on three to five dates between June and October 2018. These chlorophyll *a* results should be viewed as only part of the picture; phytoplankton quality, such as species identity and biochemical composition, as well as quantity, may affect oysters.
