COASTAL ADAPTATION VISION FOR NAVAL BASE VENTURA COUNTY POINT MUGU

Prepared for
The Nature Conservancy and
Naval Base Ventura County

September 2020

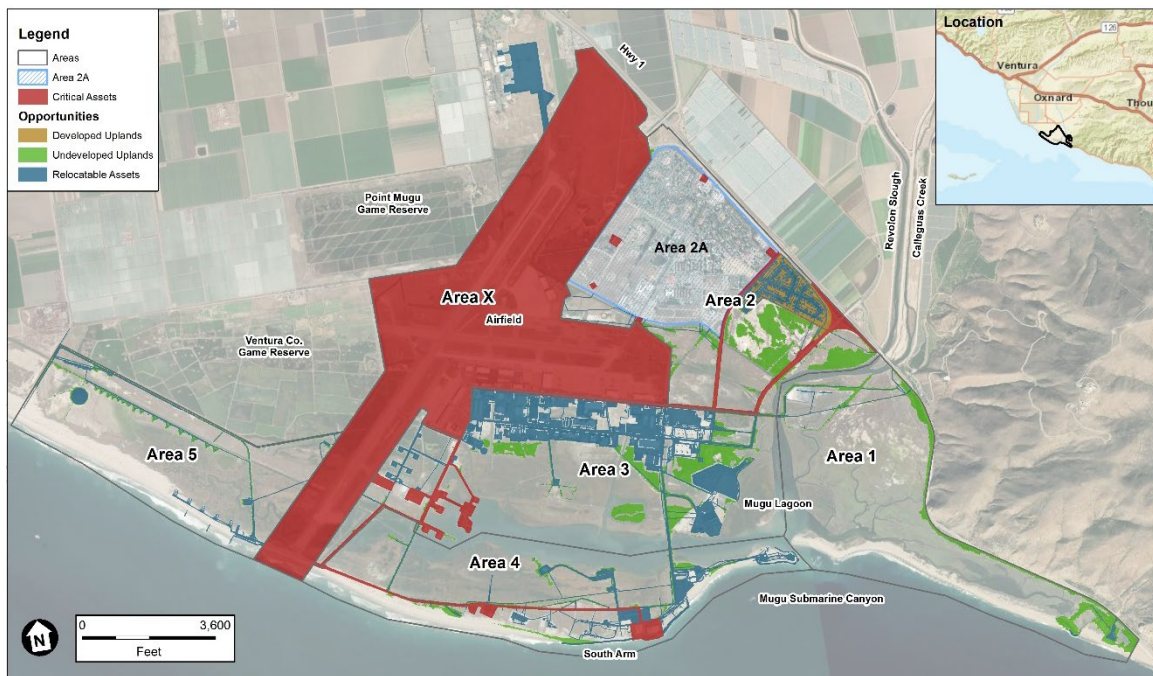
Figure ES-1
Adaptation Vision Opportunities and Constraints at NBVC Point Mugu

The Adaptation Vision is summarized in Figure ES-1. Critical asset areas (red) are maintained in place, assets (blue) in Areas 3, 4, and 5 are relocated to Area 2A or removed altogether, these and the remaining fill area (brown) are restored along with the restoration and or enhancement of adjacent uplands (green). There are assets in Area 5 and east Area 1 that cannot be moved to Area 2A owing to safety regulations and hence their locations may be optimized after specific study.

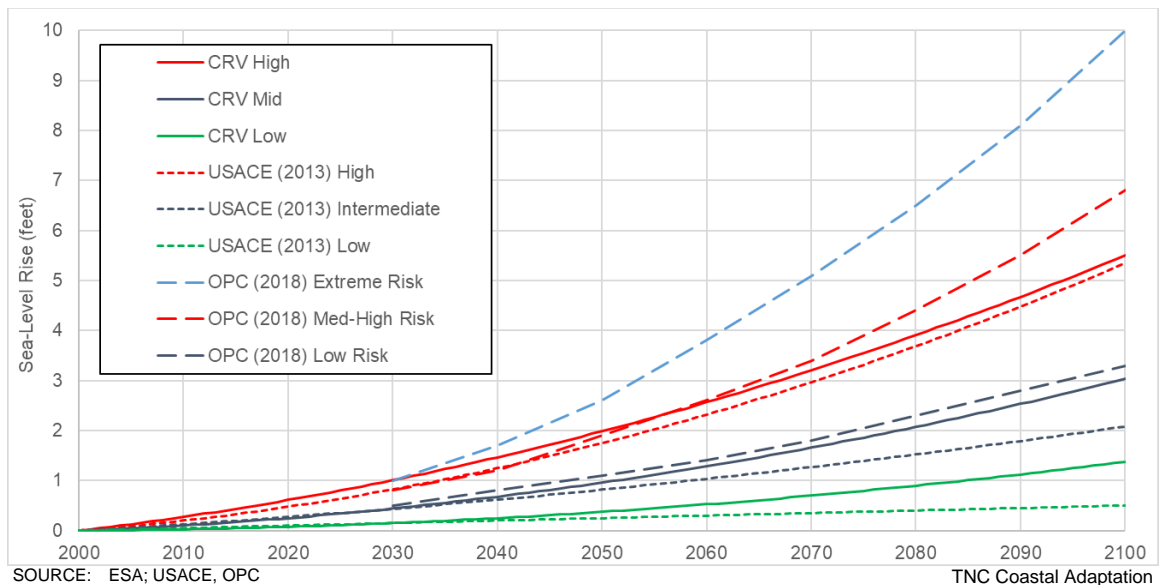
Figure 2
Sea Level Rise Projections from Various Guidance

Since the CRV scenarios for sea-level rise were developed using the best available guidance for California at the time (NRC 2012; OPC 2013), state guidance was updated in 2018 (Griggs et al 2017; CNRA & OPC 2018). As shown in **Figure 2**, the CRV High scenario tracks similarly to the 2018 Medium-High Risk Aversion low emission scenario but diverges from the Medium-High Risk Aversion high emission scenario after 2060, and is 1.3 feet lower than this scenario by 2100. The differences with the H++ scenario are much greater, and the projections diverge sooner.

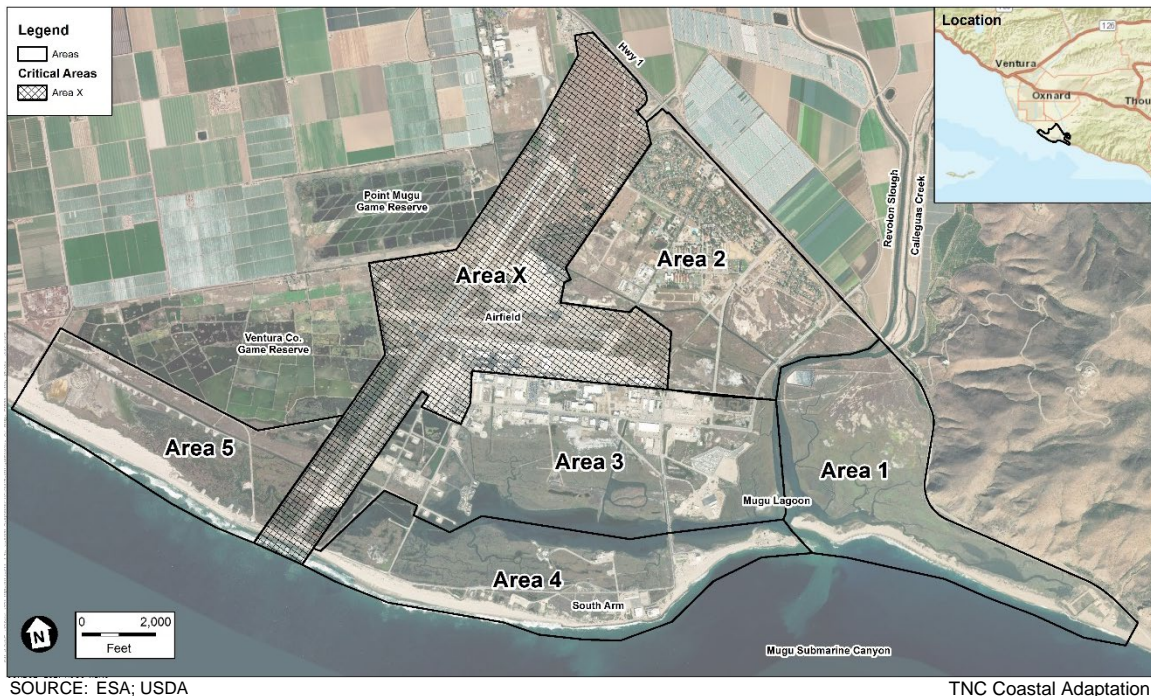
Figure 8
Analysis Areas at NBVC Point Mugu

ESA worked with TNC and NBVC staff to delineate analysis areas on the base that were used to organize the Adaptation Vision. The Analysis Areas are shown in Figure 8. Area X was designated to encompass mission critical assets that shall be maintained in place to ensure the continuity of the military mission within the context of the Vision.

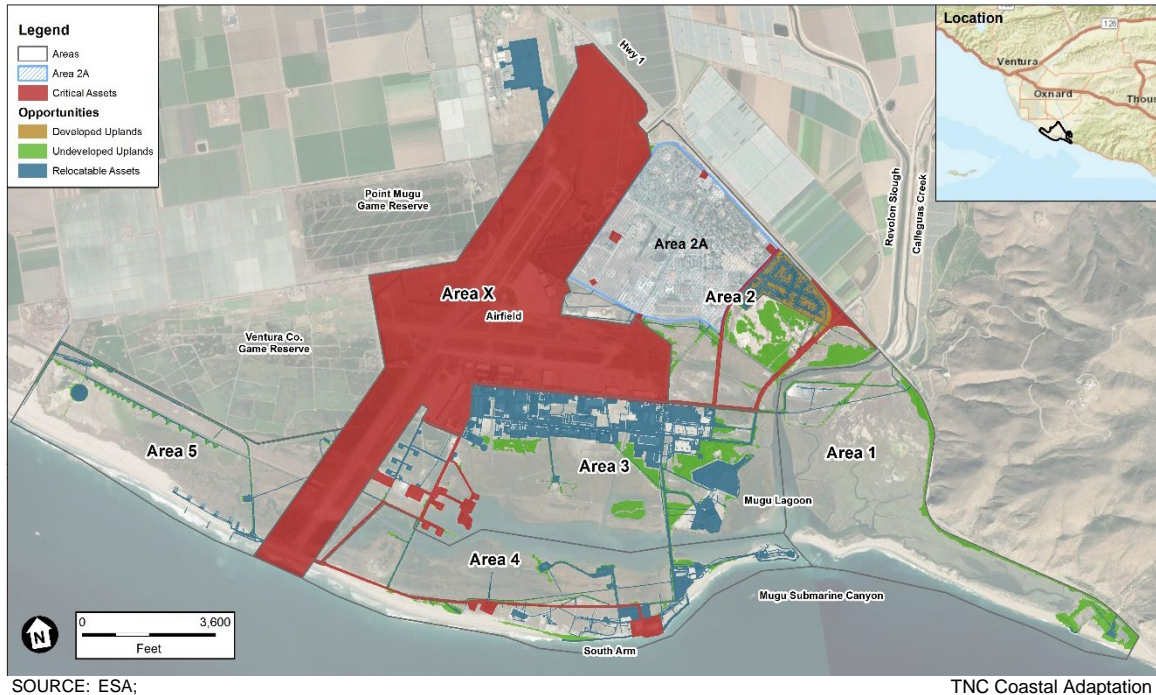
Figure 12
Adaptation Opportunities and Constraints at NBVC Point Mugu

Opportunities and constraints mapping was updated and refined to include access roads and utilities that serve the critical assets outside of Area X and 2A. Figure 12 shows the various constraints and opportunities on the base. Critical assets shown in red include the airfield and supporting infrastructure (Area X) and other facilities in Areas 2, 3, 4, and 5, as well as entrance access to the base. Area 2A (light blue hatch) could receive the relocated/realigned assets from elsewhere on the base and be protected over time. Opportunities are represented by assets throughout the base that are removable/relocatable and associated developed uplands and undeveloped uplands. Undeveloped uplands (green) include filled areas within the lagoon that could be restored to wetlands or used as other natural infrastructure features. Note there are assets in Area 5 and east Area 1 that cannot be moved to Area 2A owing to safety issues and hence their locations may be optimized after specific study.

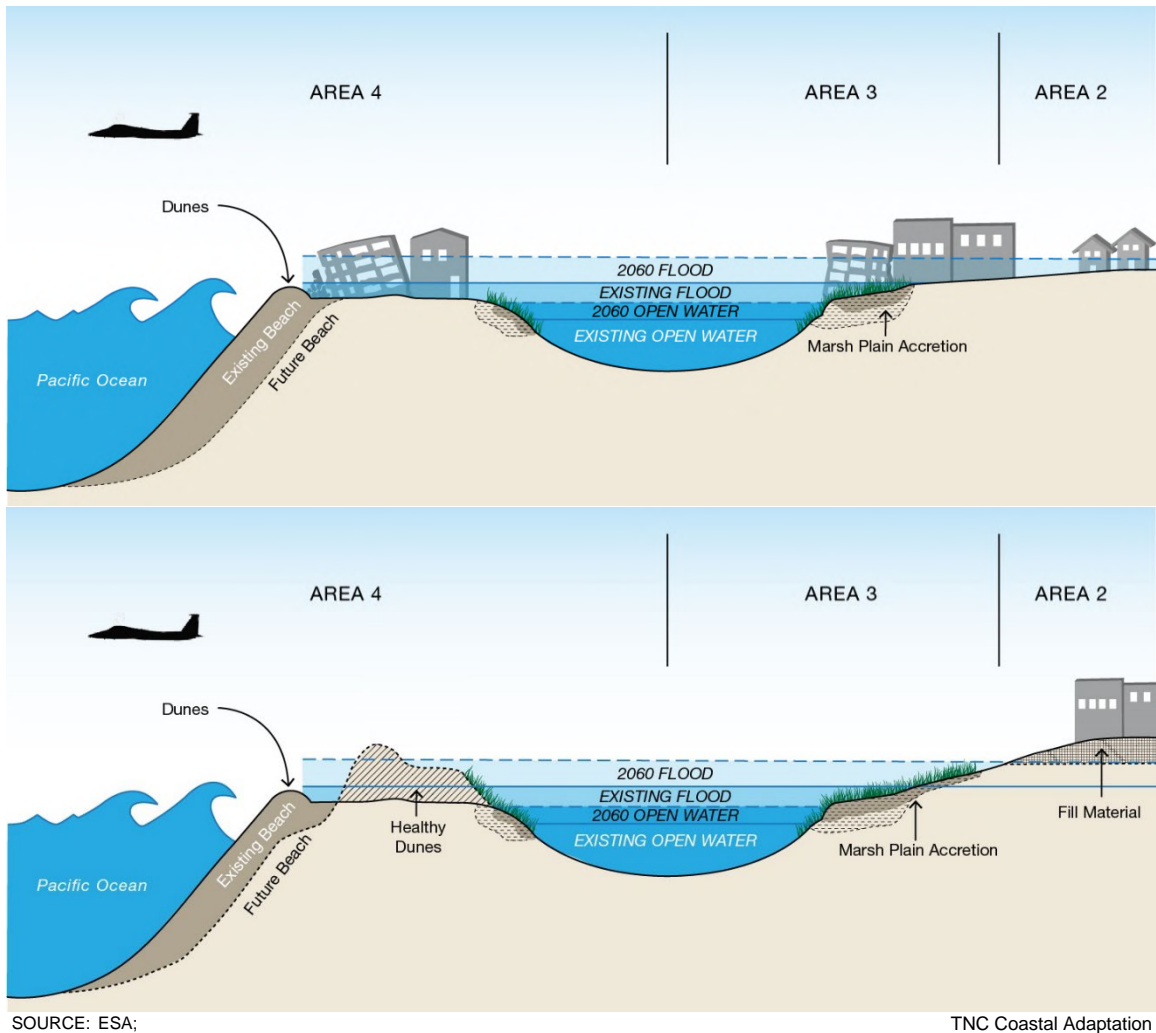
Figure 13
Conceptual Schematic of No Action Baseline (top) and
Adaptation Vision (bottom) for NBVC Point Mugu

The conceptual diagram in Figure 13 illustrates the baseline hazard impacts (top) and implemented Adaptation Vision (bottom) at 2060. The diagrams show a theoretical cross section extending from the ocean, across the beach strand in Area 4, through vulnerable assets in Area 3 and up to higher ground in Area 2A. Solid water surface lines represent the existing tidal (open water) and flooding elevations while 2060 conditions are represented by dashed water surface lines. Future sea-level rise will impact assets along the beach strand and within the lagoon, as shown in the top frame. By relocating exposed assets instead of armoring and maintaining them in place, the restored natural habitat can flourish while providing protective services. Adaptation Vision benefits to built and natural assets are depicted in the lower frame. Dunes that are allowed to migrate landward and upward with sea-level rise can limit ocean wave overwash along the beach strand. Similarly, restored/enhanced salt marsh in the lagoon and/or wetland transition slopes can attenuate wind-waves in the lagoon and limit flooding impacts to upland built assets.

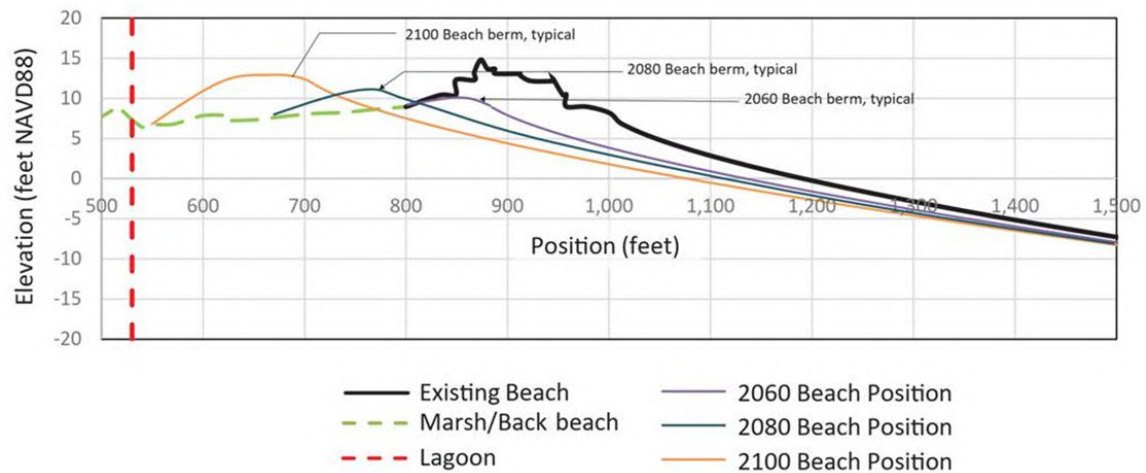
Figure 14
 Conceptual Schematic of Future Shore Migration at Ormond Beach,
 vicinity of Arnold Road, upcoast from NBVC Point Mugu

The Adaptation Vision calls for built assets to be removed from the strand, thereby allowing the shore to migrate landward but maintain its high beach and dunes which provide protective services to the Mugu Lagoon and built base assets in Areas X and 2A. Figure 14 provides a projection of shore migration just north of NBVC Point Mugu at southern Ormond Beach, near Arnold Road (ESA 2019). This figure shows the transgression (landward and upward migration with sea-level rise) induced by waves building the beach and wind building the dunes.

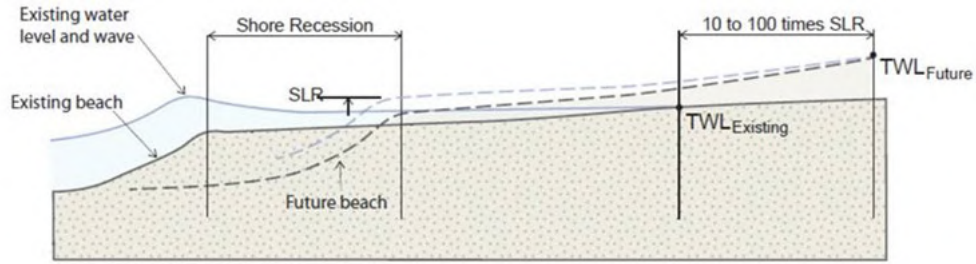
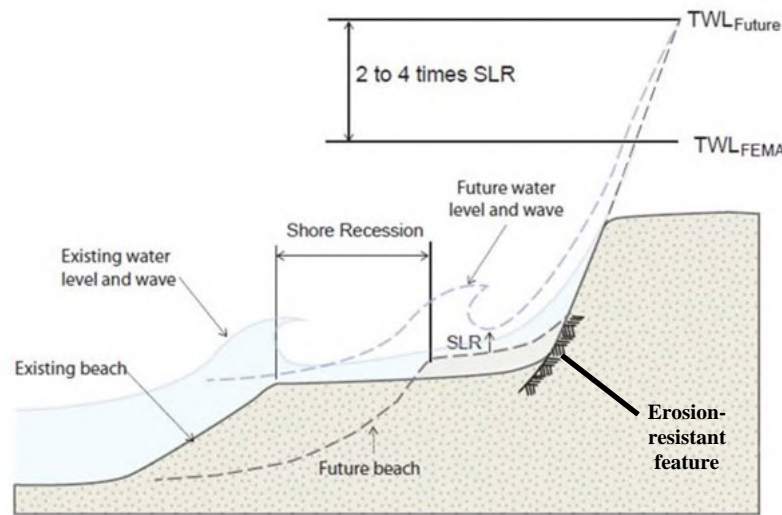
Erodible backshore: $TWL_{future} = TWL_{existing} + SLR$ and shore recession

Erosion resistant backshore: $TWL_{future} = TWL_{existing} + (2 \text{ to } 3) SLR$

Shore Morphology response to sea level rise and effect on total water level for erodible (top) and erosion resistant (bottom) backshores. These are schematics, and not to scale: Specifically the shore recession (top) should be 10 to 100 times the SLR but is drawn only about 2 times greater in order to fit on the page, See Figure 3.2 for computed distances.

Shore protection on a migrating shore results in a loss of beach and a deepening and steepening of the foreshore, resulting in larger depth-limited breaking waves and a non-linear amplification of wave run-up and overtopping at the shore protection barrier. Recent research indicates that run-up can be amplified at shore protection 2 to 4 times the amount of sea-level rise whereas there is no amplification if the shore can adjust by transgression (Vandever and others 2017; Battalio and others 2016). Figure 15 shows that, for an unarmored shore, the wave run-up increases with sea-level rise primarily in the inland direction whereas for an armored shore the run-up increases in a more vertical direction, with increasing hydraulic loading in the vicinity of the shore protection, including the “protected” assets (Battalio and others 2016).

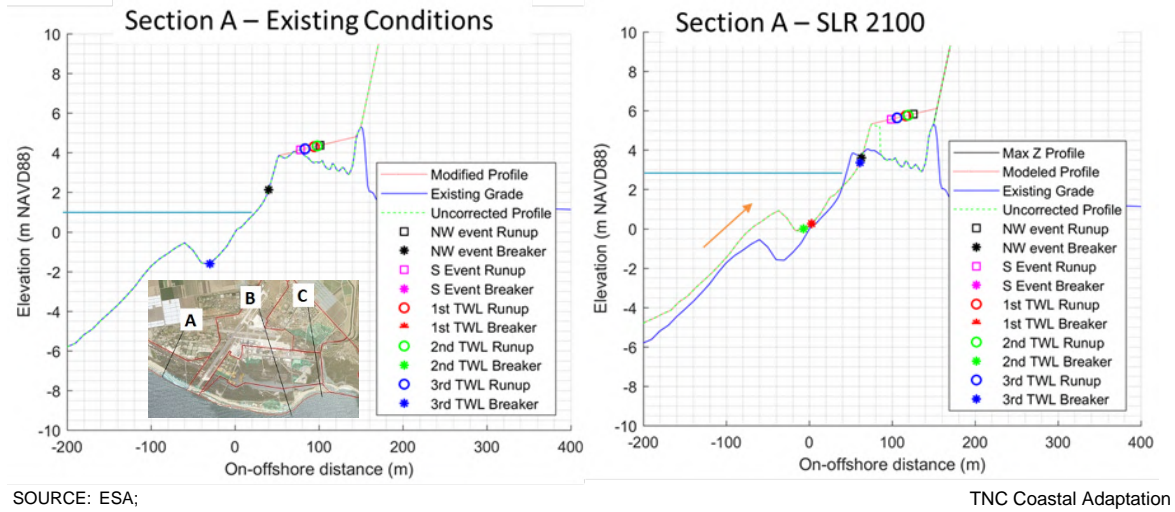
Figure 16
Wave run-up at Section A (Area 5) for existing (left) and future (right) conditions

ESA analyzed wave run-up at NBVC, building upon prior work (ESA PWA 2014; ESA 2019). As shown in Figure 16 and Figure 17. In each figure, the horizontal light blue line represents MHW elevation. The beach profile is shown as black and dashed green while the red line shows a monotonic slope projection defined for run-up computations. Five wave events were simulated as shown in the legend, squares and circles represent the landward limit of run-up while the corresponding wave breaking point is shown on the profile with an asterisk. Descriptions for each figure are provided in the next paragraph.

Figure 16 shows the wave run-up computed for Area 5 (labeled Section A), presuming the shore can migrate, for existing and future sea level at 2100. The wave run-up elevation increases about the same as the amount of sea-level rise while the entire shore profile migrates landward and up. Note that the model did not include dune building by wind (which is probable), and hence the backshore beyond the beach was not modified for future conditions. Figure 17 shows the wave run-up computed for Area 3 where massive shore protection has been installed. Note that the predicted future run-up increases more than 4 times the amount of sea-level rise, indicating a non-linear increase in wave overtopping and hydraulic loadings on armoring structures. The run-up analysis was accomplished using methods consistent with Guidelines for Pacific Coast Flood Studies (FEMA 2005) and the Coastal Engineering Manual (USACE 2003).
