# Restored Floodplain: A Case Study

## Blanchard River Watershed Hancock County, Ohio

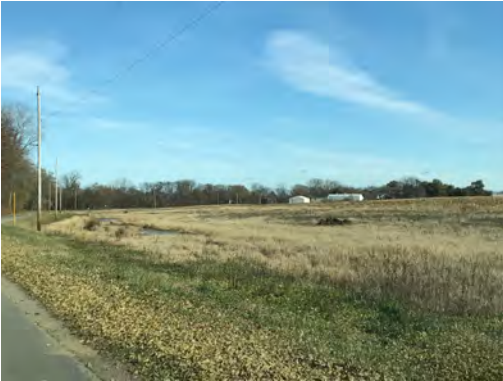
*Before Construction*

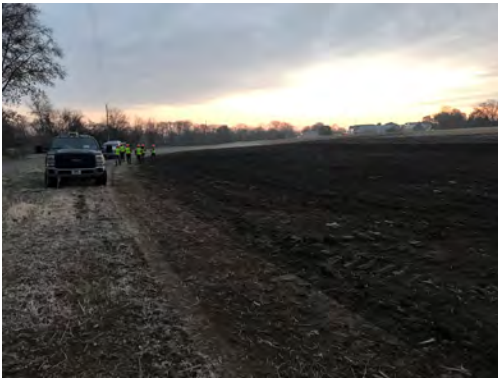
*During Construction*

We re-graded 3 acres to capture surface and subsurface water runoff and create a space for flood storage when the Blanchard River tops its banks. We planted 15 acres with 2,000 native trees, shrubs and ground cover. The native vegetation will create habitat, provide roots to help filter and clean the flood water, and offer year-round beauty for those passing by. Hancock County Commissioners own the property and wanted to demonstrate how restored floodplains, native vegetation and agricultural production can all fit into the landscape to provide clean water for both residents and for the Western Lake Erie Basin watershed. Partners will use the highly visible site for outreach and as a living laboratory for students.

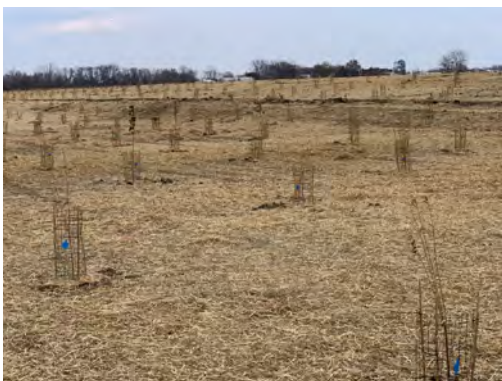
*After Construction*
